Military Aircraft Accident Summaries

MAAS 3/80

AIRCRAFT ACCIDENT INVOLVING ROYAL AIR FORCE JAGUARS GR1 XX 749 AND GR1 XX 755

Date: 10 December 1979

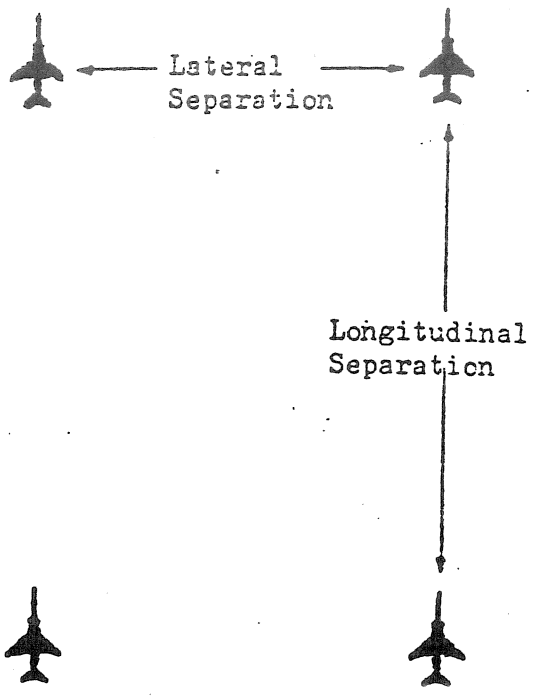
CARD FORMATION

2. The weather was good and the 4 Jaguars practised manoeuvring in different formations, eventually forming into 'Card' (see Annex). Flying at a height between 500 and 1000 ft AGL, the formation carried out several 90° turns in 'Card' without incident. The formation leader called for a 90° turn to the right; he saw the No 2 commence turning and, at the appropriate moment, initiated his own turn, losing sight of the No 2 as the latter passed behind him. The leader continued turning, expecting to see the No 2 appear behind him and to the right, but saw instead a fireball. The No 2 and No 3 had collided. The student pilot ejected but suffered serious injury; ~~the staff pilot did not eject and was killed.~~ Both aircraft were destroyed.

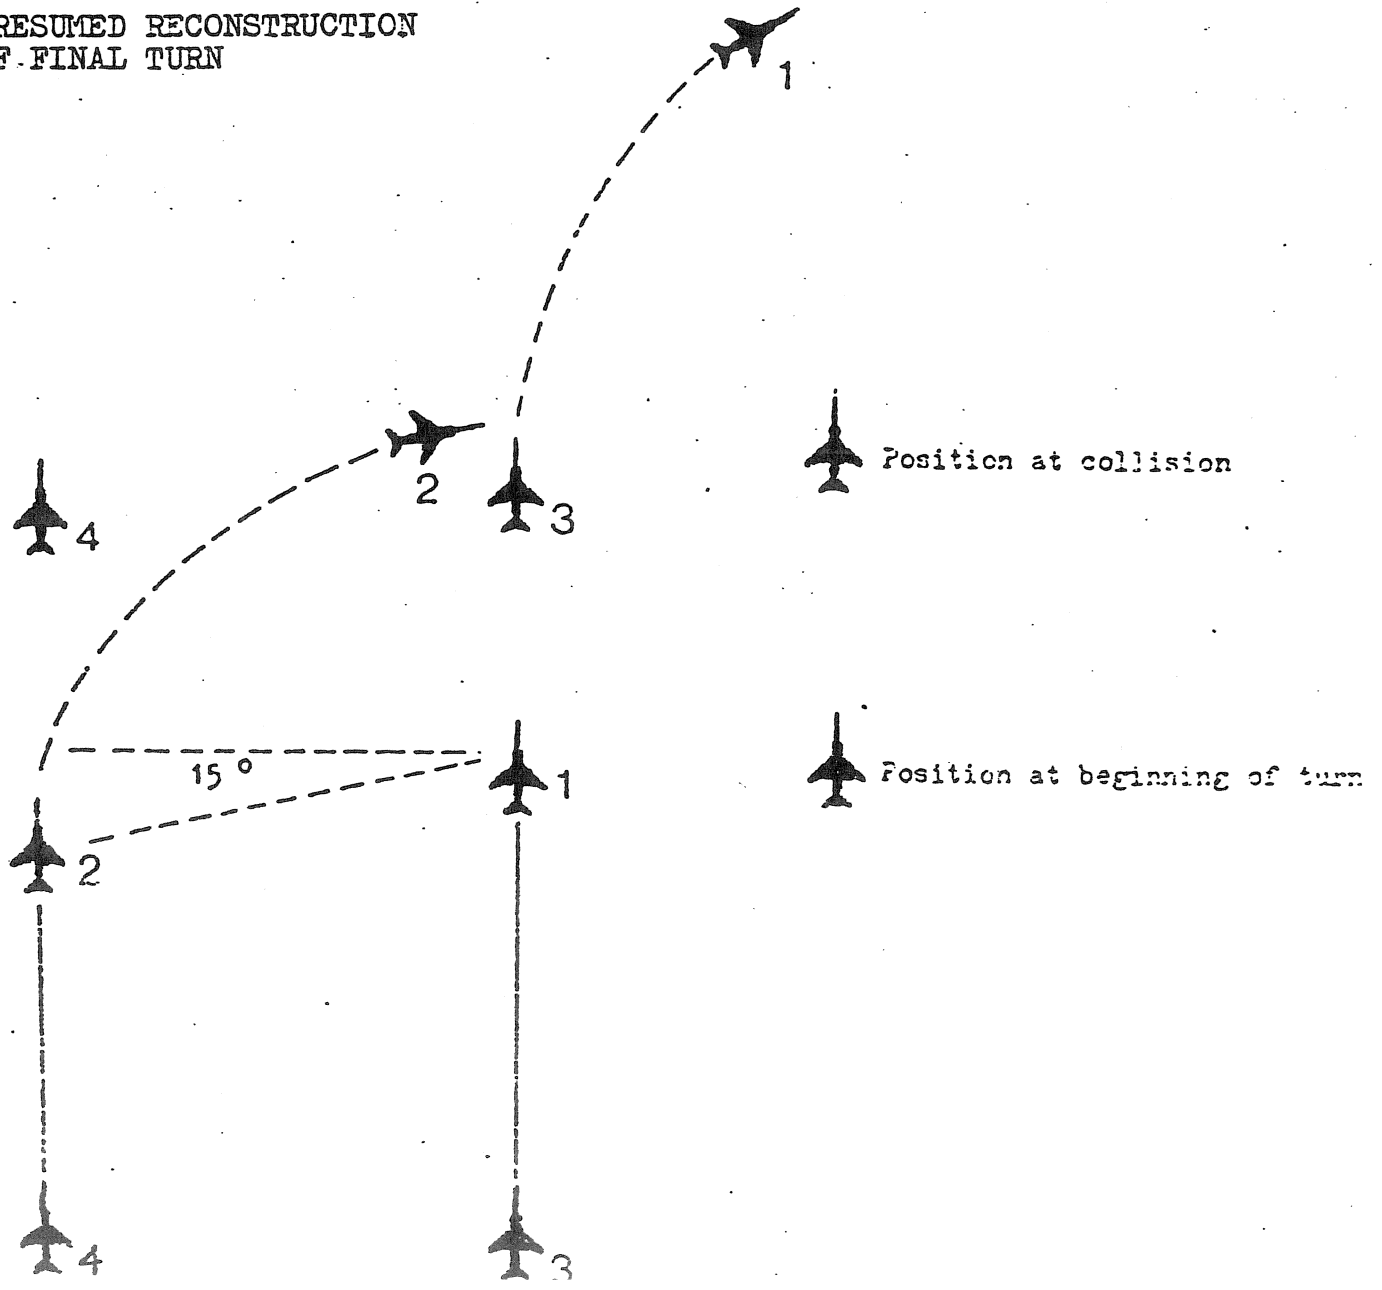
PRESUMED RECONSTRUCTION OF FINAL TURN

3. A reconstruction of the likely flight paths of the aircraft in the formation immediately before the collision suggests that Nos 3 and 4 may have been flying closer than ideal to the leading pair and that No 2 may have fallen slightly back from his line abreast position with No 1. But neither of these factors would in themselves have created a collision hazard during a routine 90° turn and the cause of the two destroyed aircraft assuming a collision course cannot be ascertained from the available evidence. A diagram showing the likely paths of the aircraft during the manoeuvre is attached.

4. In order to maintain 'Card' formation, following a routine 90° turn, the line abreast aircraft have to change stations from left to right and vice versa. This is not a hazardous manoeuvre but as an additional precaution following this accident, manuals describing 'Card' formation flying are being amended to highlight the risk of flight path confliction.
