## Military Aircraft Accident Summaries

13/88

### AIRCRAFT ACCIDENT TO ROYAL AIR FORCE PHANTOMS FG1 XT861 & XT872

Date: 7 September 1987  
Parent Airfield: RAF Leuchars  
Place of Accident: North Sea, 50NM East of Leuchars  
Crew: Two in each aircraft  
Casualties: Two slightly injured

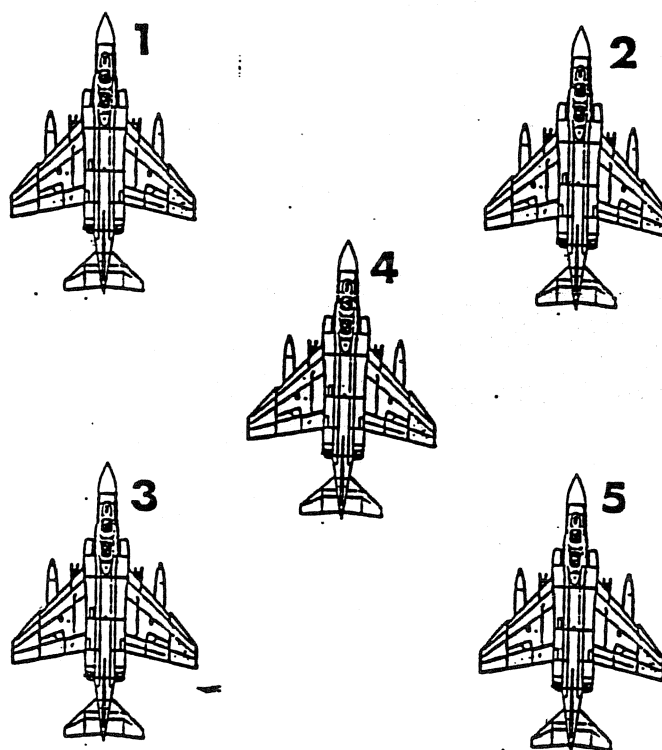
Figure 1

1. A formation of 6 Phantoms was briefed to carry out air defence training after which they would undertake close formation practice in preparation for a forthcoming air display. The close formation would include flight with 5 of the aircraft in a St Andrews Cross close formation (see Figure 1). The sortie was briefed in detail, including individual crew responsibilities and emergency actions. For the St Andrews Cross, No 4 was briefed to fly co-height with Nos 1 and 2, with Nos 3 and 5 stepped down. The No 2 navigator was allocated the responsibility for collision avoidance between Nos 2 and 4 and was to advise his pilot if No 4 was too close.

4. The investigation found that the primary cause of the accident was the decision to fly the St Andrews Cross formation with Nos 2 and 4 flying independently off the lead aircraft, on the same plane, with neither pilot having responsibility for collision avoidance.

5. The instructions and authorization for formation flying have been reviewed by HQ 11 Group and amended.
