SERVICE INQUIRY INTO AN AIRCRAFT ACCIDENT

DATE	02 July 2009		LOCATION AND GRID REFERENCE	GLEN KINGLAS, ARGYLL, SCOTLAND N 56 14 58 W 004 52 15 (D M S) 222228.378 N710035.602 (National Grid)		
AIRCRAFT TYPE		MARK	SERIAL NUMBER		PARENT UNIT	
TORNADO		F3	ZE982		RAF LEUCHARS	
NAMES OF CREW		(Pilot) Flt Lt Thompson, Kenneth Alistair Louvin		PARENT UNIT	RAF LEUCHARS	
		(Navigator) Flt Lt Morton, Nigel David			RAF LEUCHARS	
NUMBER OF CASUALTIES						
KILLED			INJURED			
CREW	PASSENGERS	OTHER	CREW	PASSENGERS	OTHERS	
2	0	0	0	0	0

SERVICE INQUIRY INVESTIGATING THE ACCIDENT TO TORNADO F3 ZE982
ON 02 JUL 09

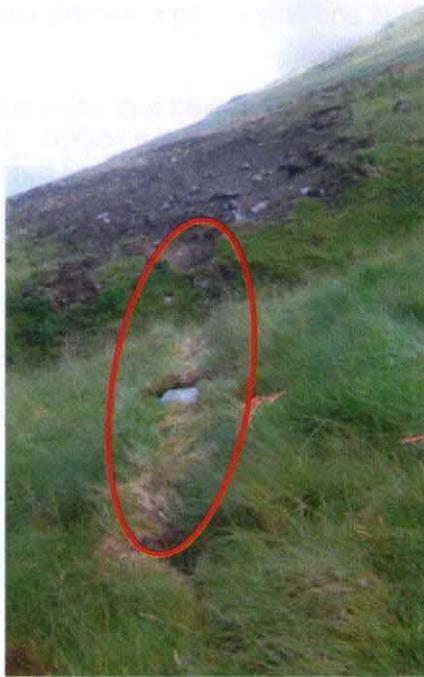
Figure 2
Initial Impact Point

b. The ac initially impacted a slight rise in the hill side with what was likely to be a fin of the left 2250L fuel tank (Figure 2). On the west side of a subsequent hollow was the main impact (Figure 3).

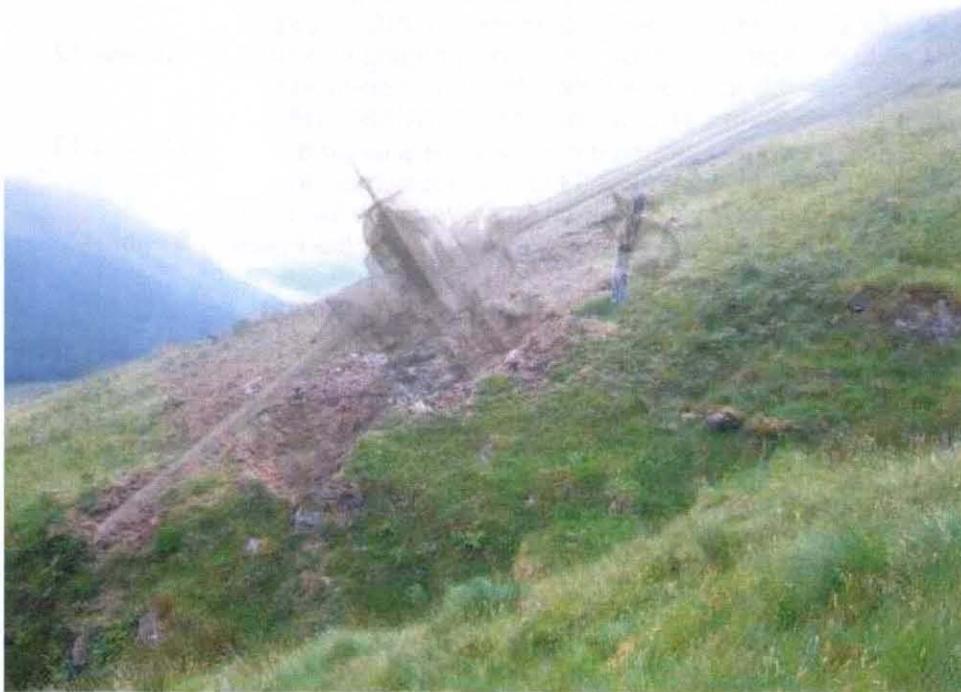
Figure 3
Main Impact Point (with ac overlay)

c. There was a large fireball on impact and the engines, wing-box and cockpit had sufficient momentum to continue in the direction of travel. The

other parts of the airframe fragmented and only the fin assembly and right taileron were found substantially complete.

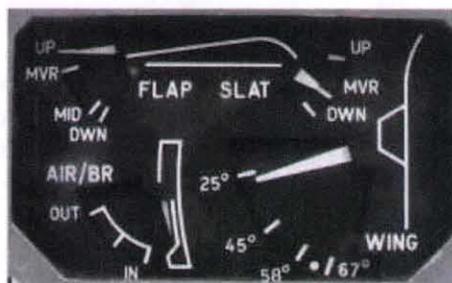
Figure 7

16. Following confirmation of the ac configuration at impact, the Panel considered the possibility of a temporary restriction within the wing sweep mechanism or both an unserviceable and/or misread Cockpit Position Indicator (CPI) as factors. Investigation into the CPI found that the graduation movement of the wing sweep indicator from 25° to 27.9° was small. A slight gauge discrepancy could easily be interpreted as the wings being fully forward (25°). With the wings fully forward (25°) the selection of MVR would have provided a flap and slat indication on the CPI as shown in Figure 6. With the wings at 27.9°, only the MVR slats would travel (Figure 7). Additionally, slat deployment could easily be confirmed visually on the leading-edge of the wing (though the flap would not have been visible). At MVR selection, the gauge movement for the flaps on the CPI is less than that of slat. The calibration of ZE982's CPI could not be proven post the accident. The final recorded check of the wing sweep was verbal by the Pilot and was carried out after selection, during a relatively benign phase of flight. The selection of MVR was carried out on entry to the series of valleys at TARBET, coincident with an increase in workload. The Panel could not rule out a combination of gauge error, gauge interpretation and/or temporary restriction as factors effecting the ac configuration at the time of the accident. Nonetheless, considering the weight of evidence, the Panel concluded that the final configuration was more likely to be as a result of mis-selection and subsequent gauge interpretation, rather than a technical event.

Likely Configuration at Accident

20. A comprehensive review of engineering documentation, ac history, cockpit voice recording, ac system parameters during the sortie (from the R-ADR and EHUMS data) and external reports allowed the Panel to conclude that ZE982's flying control systems, engines and structure were serviceable and all critical systems operated correctly during the sortie; there was no evidence to prove that a technical event caused the loss of ZE982. However, the panel could not positively determine why the ac was in 27.9° wing sweep.

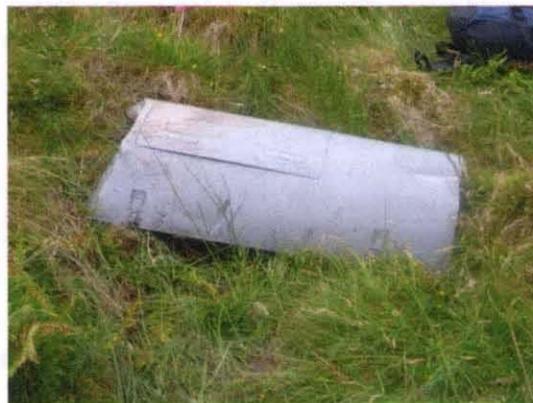
Figure 4

19. **R-ADR Identification.** The R-ADR was not found at the crash scene until day 4. The R-ADR was found within its associated spine panel (Figure 4) and, as there were no associated external marking, the spine panel was frequently overlooked.

The Panel observed that the R-ADR spine panel of ZE982 was not marked, thereby directly contributing to the delay in recovery of the R-ADR. Additionally, the internal colour of the R-ADR bay was no different to the rest of the ac's internal finish. Also, the organisations in attendance at the crash site were not fully aware of the DEF STAN symbol for a flight data recorder.

- f. The R-ADR panel markings did not meet DEF STAN requirements, thereby compromising the ability for this important item to be located.
 - g. The failure of the NAU has been a known issue across the fleet for a number of years that has yet to be addressed.
