MAA DG/SI/01/11 SI ZG792

**SERVICE INQUIRY INVESTIGATING THE ACCIDENT TO TORNADO GR4 ZG792
ON 27 JAN 11**

**MILITARY AVIATION AUTHORITY
PROCEEDINGS OF A SERVICE INQUIRY
INTO AN AIRCRAFT ACCIDENT**

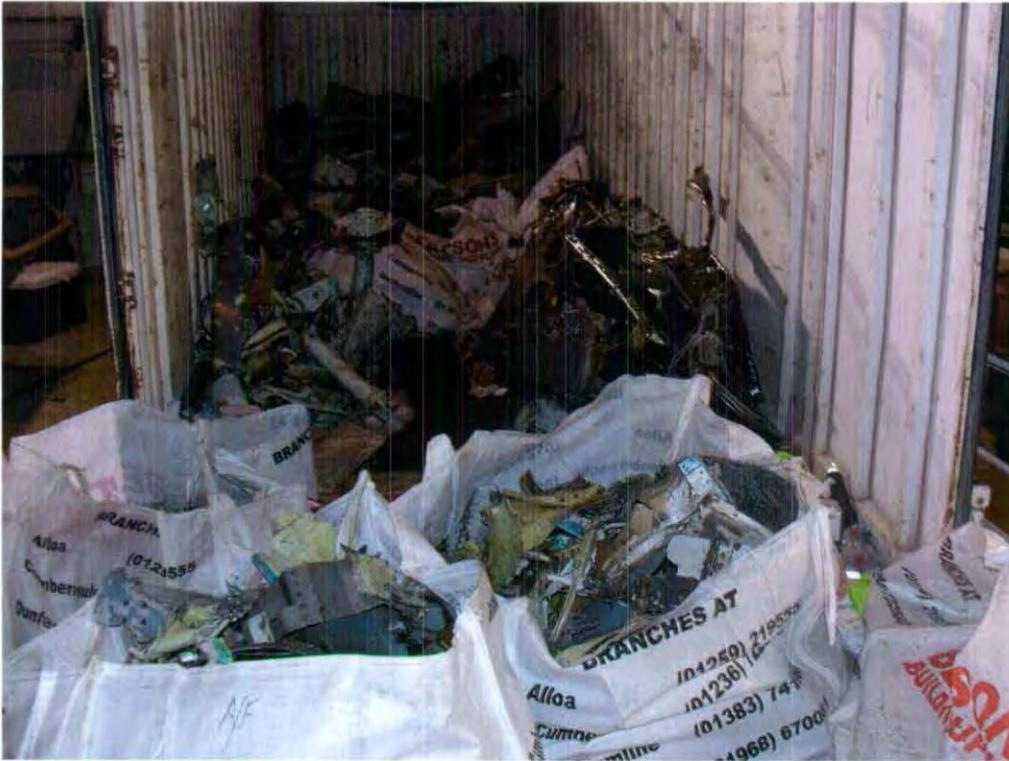
Figure 1 - One of two ISO containers housing the recovered parts of ZG792.

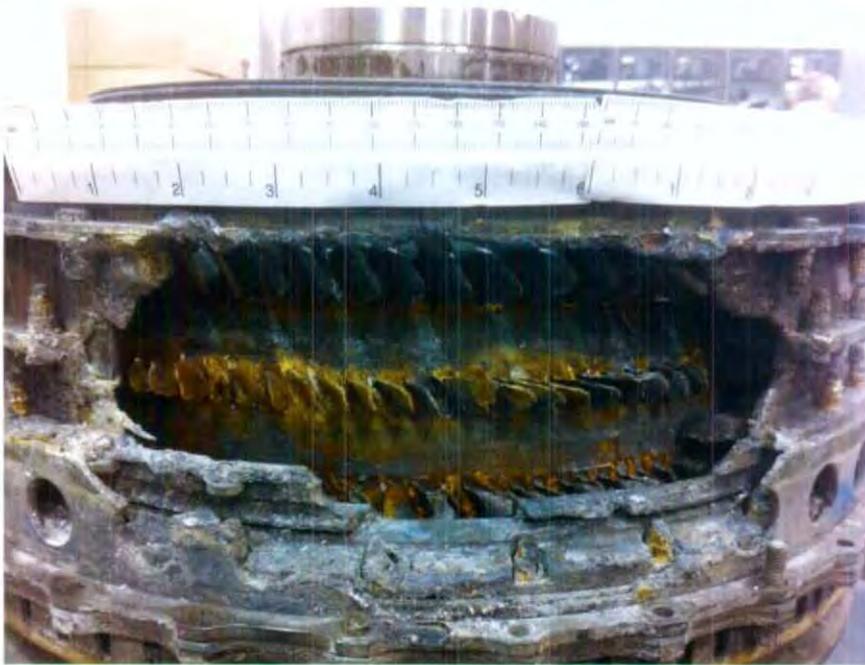
7. **Right engine examination.** Following initial interviews with the crew of ZG792, the Panel focussed its initial investigation on the right engine. On recovery, it was found to be approximately 1 meter shorter than its original design length and debris from the ac intake was found in the LPC stage; both of which were attributable to impact damage with the sea. Evidence of burnt wiring looms were evident and clear evidence of breakout was found in the HPC casing, as shown in Figure 1.

Figure 1 - HPC Casing Damage

10. **Ti fire.** The Panel observed evidence of a 'hot-spot' on the HPC inner casing at the HPC stage 2 stator vanes and HPC stage 3 rotor blades area, indicating the origin of a Ti fire. A number of trailing edges of the stage 2 stator vanes in this area were found to have burned. The edges of the

breach of the HPC casing as shown in Figure 1 were found to be molten in appearance. This type of breach with molten edges is typical of a Ti fire. The Panel are of the opinion that debris, which had originated as a consequence of the initial failure, became lodged in the stage 2 stator vanes, overlapping into the stage 3 rotor blades path and was caught on each blade as it rotated. Titanium ignites at a lower temperature than it melts and has a low conductivity of heat. Hence, heat will not have been readily conducted away from the initial source and the titanium components will have rapidly risen in temperature to the ignition point. Ti fires are fast burning with a high heat intensity and contain molten particles. In-service experience shows that the time taken between the start of a Ti fire and breakout of the engine casing on Tornado can be in the region of 2 to 3 seconds. Given the damage observed, it is highly probable that molten particles found in the Ti fire burned through the compressor casing resulting in a radical expulsion of molten or incandescent metal which originated from the HPC.

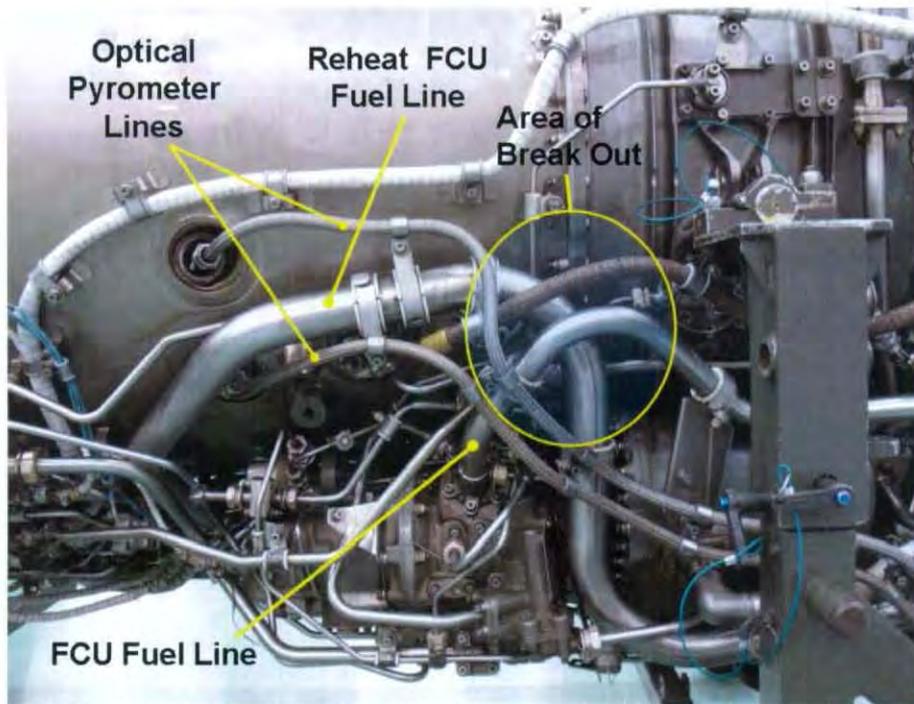
11. **Breakout.** Analysis of the engine examination indicated that there was a breach in the HPC casing, the Combustion Chamber Outer Casing (CCOC) and the by-pass duct. The Panel concluded that the Ti fire containing molten particles which originated in the HPC, burned through the CCOC and then the by-pass duct. The breakout location was in the region of the engine main and reheat fuel lines, highlighted in Figure 2. Optical pyrometer lines which run through the breakout area were recovered with fire damage to the outer braiding, supporting the conclusion that the fire broke out of the engine outer casing. The Panel were unable to locate the main fuel supply line, however 2 segments of the reheat fuel supply line were recovered originating from the breakout area; the material in the centre of this area, the direct path of the Ti fire, was not recovered. On examination of these segments, perforations in the pipeline wall and evidence of fire damage on both internal and external surfaces were found. Deposited titanium was also discovered on the pipeline outer surface. Hot spots were identified on both pipe sections; further sectioning revealed cracks emanating from the hot spots. Given the available evidence, the Panel considered a number of possible scenarios that may have caused the fuel line rupture:

- a. The Ti engine fire may have penetrated outboard to the reheat fuel line causing it to rupture at a hot spot.
- b. Violently ejected heated material impacted the fuel line causing failure at a hot spot.
- c. Violently ejected material impacted the fuel line causing overload failure.

The Panel could not positively determine the exact cause of the fuel line failure.

Figure 2 – Area of breakout indicated on a serviceable engine

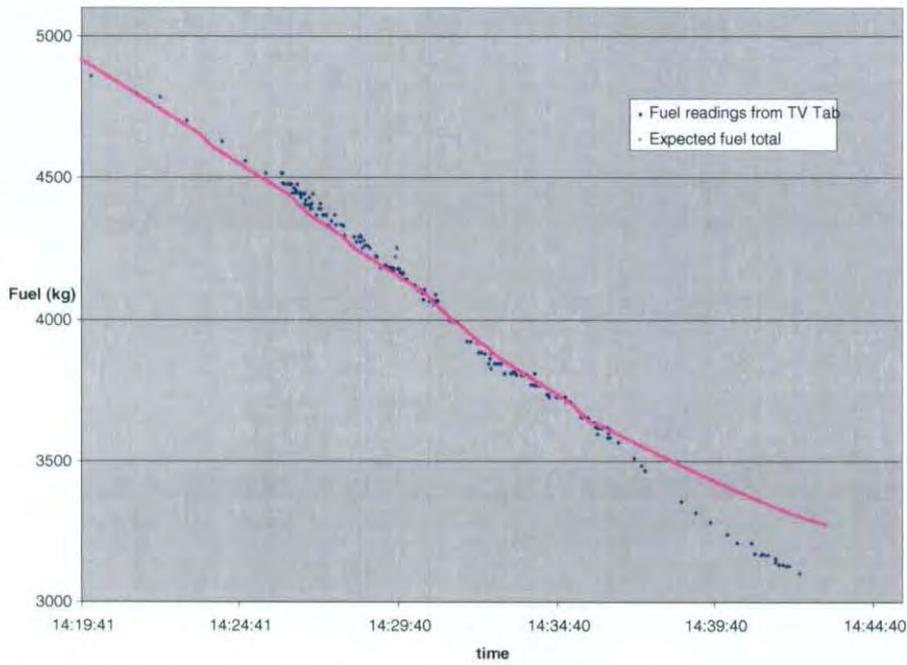
Figure 3 - Predicted and actual fuel use

Figure 3 shows the predicted and actual fuel usage from 1420:00 (T-15:46) onwards, covering the low-level portion of the sortie, through the initial point of the Mech fail at 1435:46 (T0:00) through to 1442:23 (T6:37) of the accident sequence, which is the last usable fuel figure available from the VRS.

13. Figure 3 clearly shows that the fuel usage rate is as would be expected in normal flight up until the initial point of the Mech fail. From T0:00 onwards, however, the predicted and actual fuel usage rates diverge, with approximately 200kg more fuel being used than would have been expected. This can be more clearly represented in Figure 4, which shows the time from T0:00 onwards. This graph shows 2 predicted fuel lines, one calculated from the previous figures, and the other showing the calculation worked backwards from the last known fuel totals. The delta between the lines represents the fuel discrepancy of approximately 200-250kg.

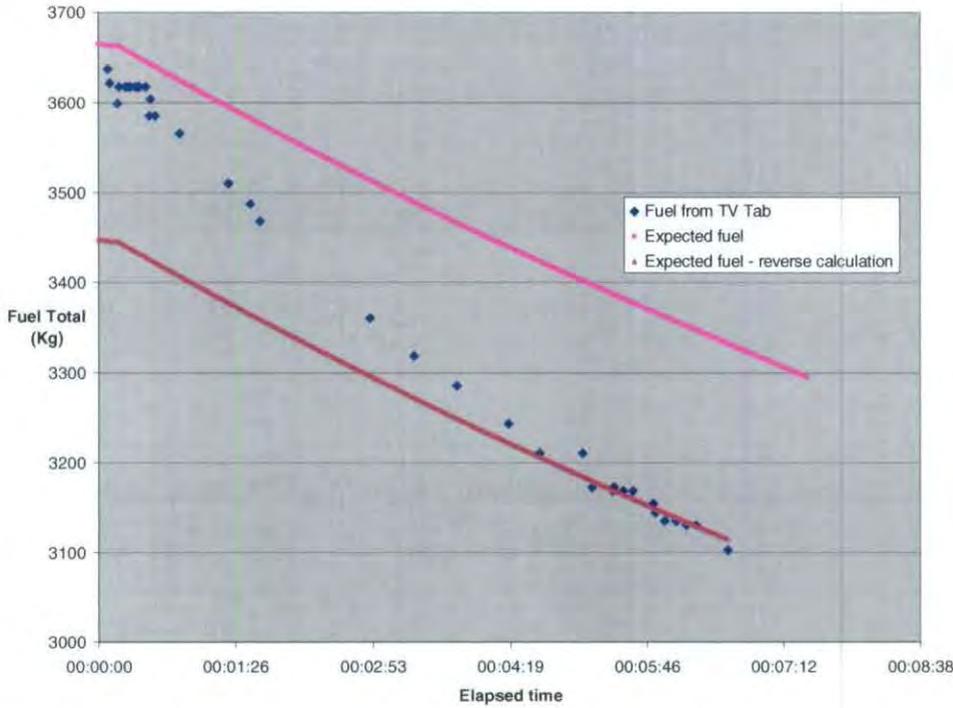
Figure 4 - Predicted and actual fuel use during accident sequence

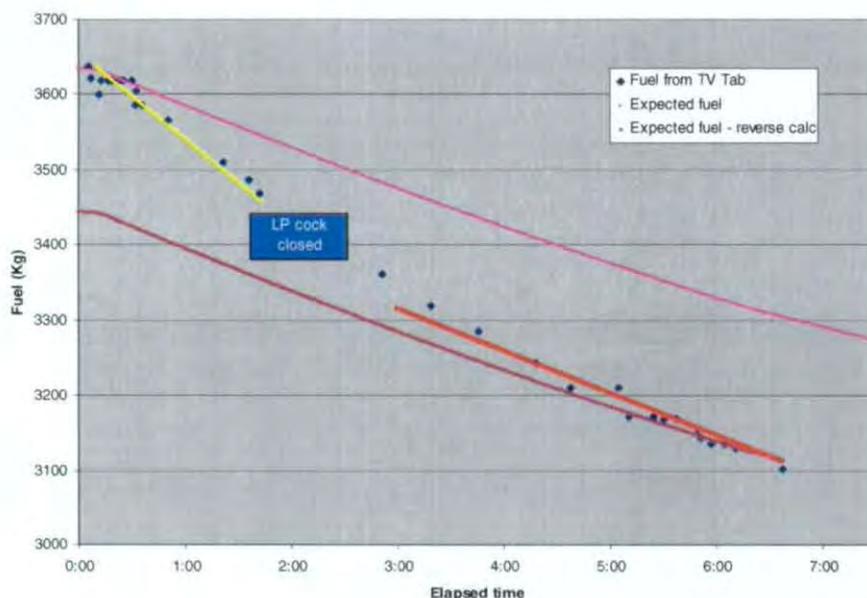
Figure 5 - Fuel Flow graph - LP Cock closure at T1:00 theory

The rate of fuel flow can be drawn at the rate shown in Figure 5. The actual fuel usage shown in this figure indicates that the majority of the abnormal fuel usage occurred in the early stages of the accident sequence. This theory is supported by the evidence of fuel pooling found in the right engine bay door, which suggests fuel pooling fed the left engine fire. In this presentation, by approximately T3:00 the fuel usage rate had returned to that expected of an ac running with one engine at max dry in the same flight conditions as CACTUS 2 prior to the ejection. Allowing some time for the fuel figure to catch up with the correct fuel total and for the fuel already in the pipe downstream of the LP cock to leak, the Panel concluded that if this theory is correct, the pilot closed the LP cock at some point around T1:00 just before he pressed the fire buttons.

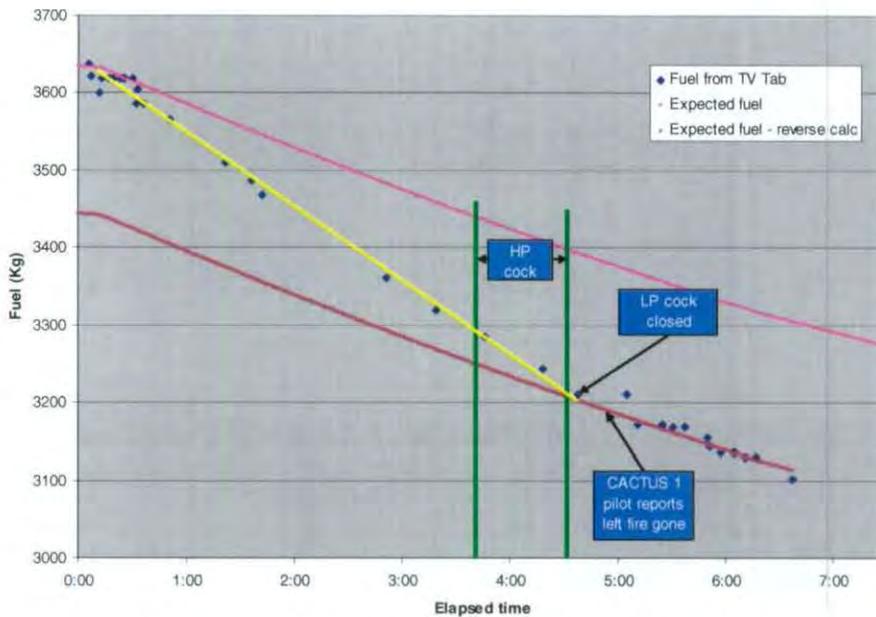
16. **LP Cock not closed until T4:30.** Using the same fuel burn and fuel total figures from Figure 5, the Panel considered a theory that, contrary to the pilots assertion, the LP cock was not closed until after the aborted right engine relight attempt. Using the estimated fuel leak data (approx 250kg) the Panel were able to use the BAE Systems fuel drainage report in Annex F and ascertain that this fuel would have resulted in a pool of fuel of approx 0.18m deep within the engine bay. Using the BAE Systems model, the Panel were able to ascertain that, at a depth of 0.18m, this fuel should have drained away from the ac in approx 15-25s. Had the LP cock been closed at T1:00 then, in theory, this fuel should have drained away by approx T1:25. In reality the visual signs of fire were not seen to extinguish until T4:53. The Panel were unable to explain why the fire had continued, unless there was an additional source of fuel.

Figure 6 - Fuel flow graph - LP Cock closure at T4:30 theory

The average rate of fuel flow can also be drawn as in Figure 6. This shows that the actual fuel consumption is relatively constant up until the point the re-light is aborted, implying a steady and continuous leak. Had the LP cock been left open, it is possible that any damage sustained by the main and reheat fuel lines could have been the continuous source of fuel into the right engine bay. It is possible that, in the confusion that the pilot felt during the initial stages of the accident sequence, he omitted to shut the LP cock as his natural flow would have been interrupted by the emergence of the L FIRE caption. During interviews with the Panel, the pilot stated that the onset of the L FIRE caption happened just as he closed the HP cock on the right engine. He used this to explain how his drills had become delayed. However the Panel was able to ascertain from R-ADR data that there were 8s between closing the HP cock and the onset of the L FIRE caption. Whilst it may be reasonable to expect the pilot to have spent some of this time observing the right engine instruments (to ensure the engine was correctly winding down) it could not explain this process taking 8s. The Panel opined that there was sufficient time in the 8s gap, between HP cock shut and L FIRE, to have made the selection of LP cock shut. Although the pilot commented that he completed most of his drills silently, he actually verbalizes more than he recalled. During the initial onset of the emergency he verbalizes all his diagnosis and his actions (such as selecting 25° wing sweep). He also verbalizes the action of closing the HP cock (T0:38), and confirms this action when it is complete (T0:43). Later on during the emergency, at T2:25, he further runs through his actions with the crew of CACTUS 1. He states that he has shut down the right engine, the cross drive has closed and then, at T2:40, that he had pressed both fire buttons. At various stages throughout the emergency he verbalises every one of his actions, apart from the shutting of the LP cock. This action is not mentioned at any stage in the emergency. When the pilot attempts to relight the engine at T3:40, a few seconds after opening the HP cock (T3:44) the Panel believe

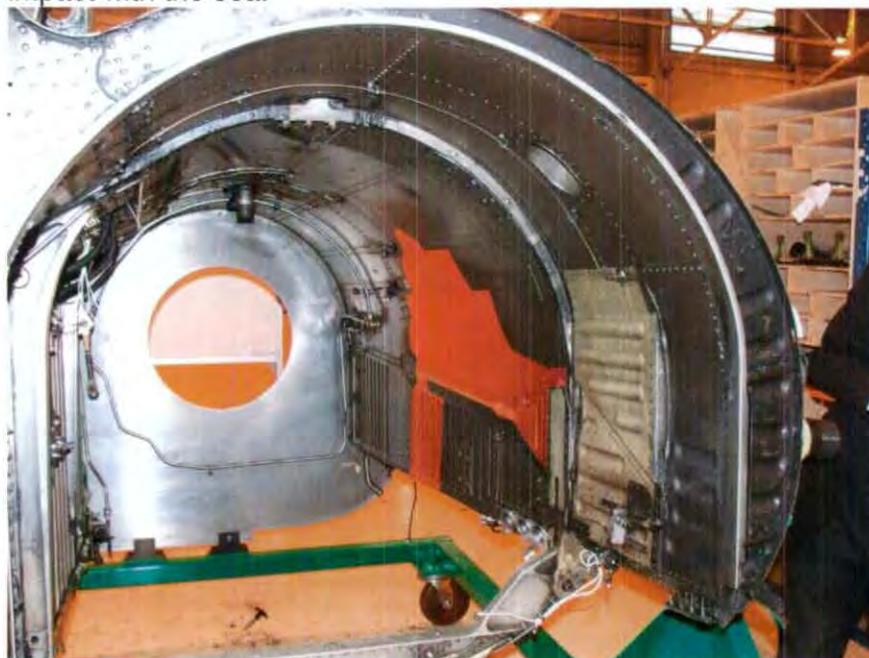
22. **Right engine bay fuel fire.** The forward right engine bay door was badly damaged and showed visual evidence of sooting and heat damage. The distribution of the sooting showed evidence of 'tide marks' suggesting that fuel had pooled in the door and burnt away leaving these marks. Both the left and right rear engine bay doors were not recovered and hence it is not known whether these were lost during impact or were significantly damaged by fire during the accident sequence. Scottish Military Air Traffic Control reported a small radar return falling behind the ac at this time. The Panel concluded that this was most likely to be a rear engine door. The right engine bay titanium firewall was recovered and showed visual evidence of 'blueing'. This highlighted that there has been excessive heat applied to the titanium firewall. Following the rupture in the fuel line, a combination of fuel, fuel vapour and fuel spray would have filled the right engine bay. The following sources of ignition were considered:

intense fire reached in excess of 635°C and destroyed much of the aluminium structure on the engine bay doors, on which a large section of the fire wire is mounted. It is therefore highly likely that the fire wire was damaged, resulting in intermittent warnings, and then final failure. Ongoing investigation by MilAAIB aims to engage with the fire detection system manufacturers in order to assess the effects of fuel cooling on the fire wire and the effects of radiated heat on the controller.

Figure 15 - Representative area of right firewall recovered

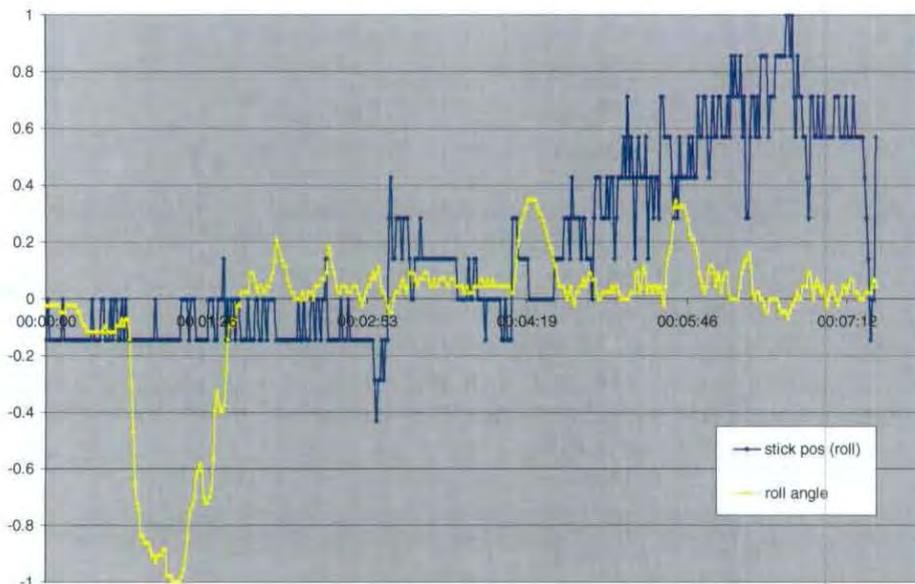
Figure 16 - Normalised lateral control data (+ve = right)

Given the pilot's recollection of events shortly before ejection and the data displayed in Figure 16, the Panel conclude that there was a gradual loss of control of the right taileron, as the mechanical control rods deformed due to heat damage. This gradual loss of control ultimately led to the decision by the pilot to eject.
