Service Inquiry

Griffin HT Mk1
ZJ241, Snowdonia

09 August 2016

SERVICE INQUIRY INTO THE ACCIDENT INVOLVING A GRIFFIN MK1 ZJ241 AT YR ARAN, SNOWDONIA, WALES ON 9 AUG 16

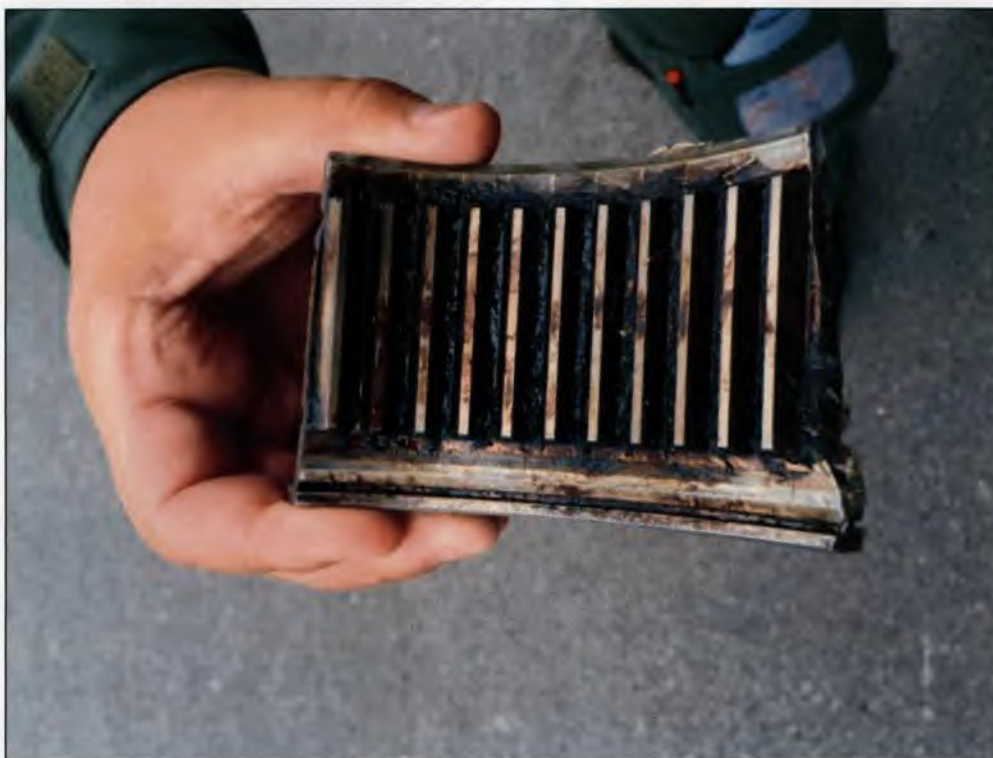
Exhibit 18

Figure 4 - Fragment of driveshaft coupling found by the awaiting Passenger.
(Picture Source: Passenger)

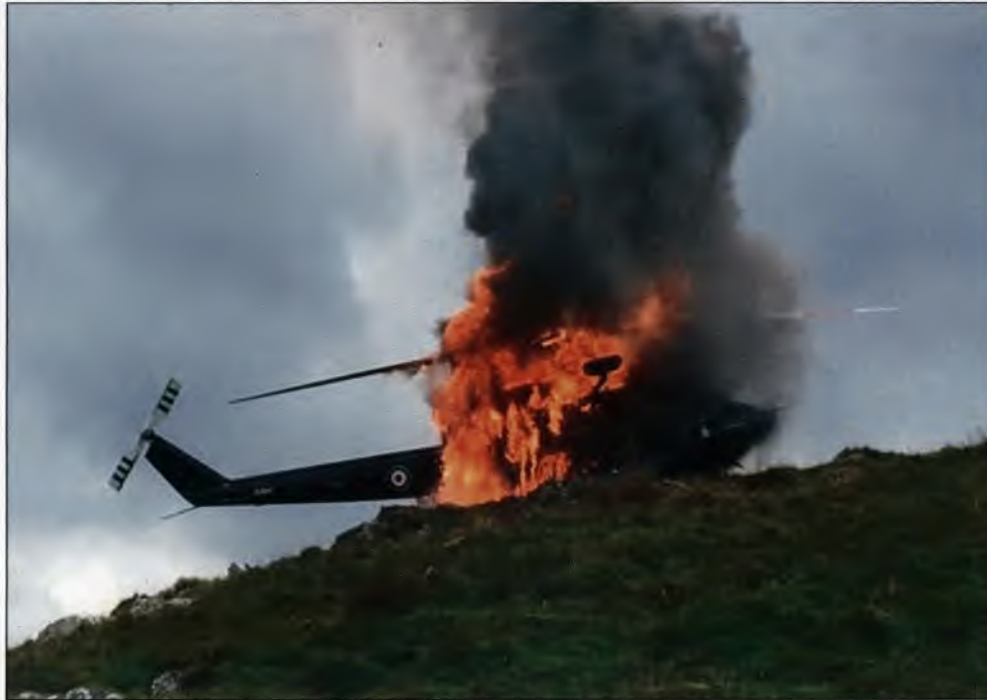
Figure 5 - Aircraft fire approximately 5 minutes after the accident.³¹
 (Picture Source: Aircraft Commander A)

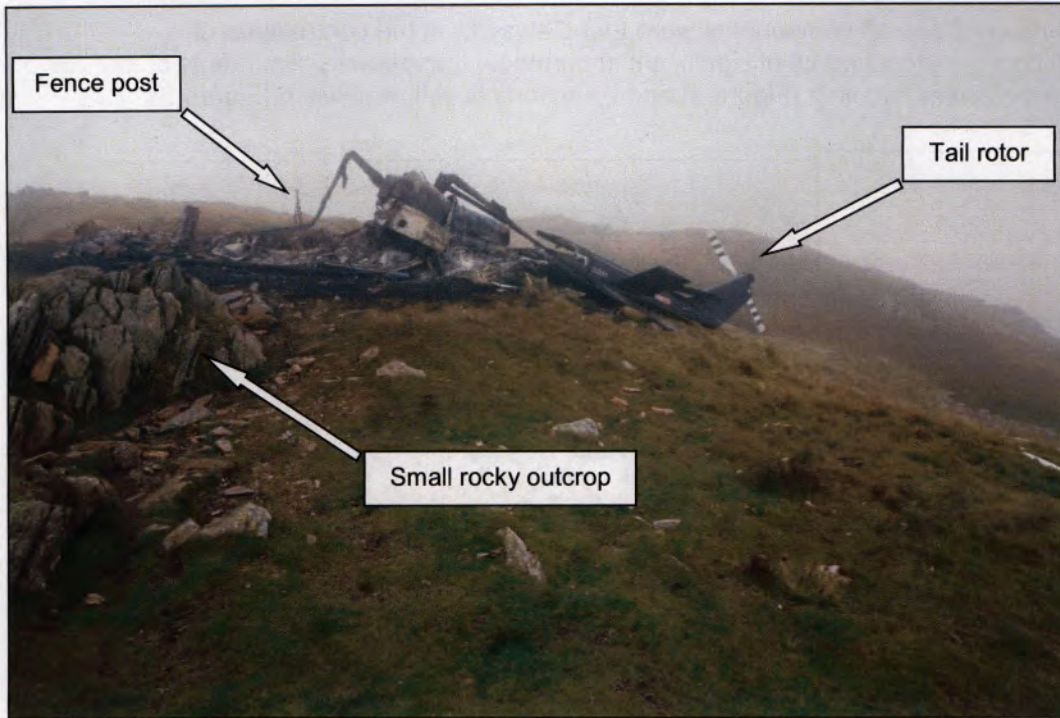
Figure 6 - Aircraft wreckage, adjacent to a small rocky outcrop.
(Picture Source: DAIB Engineering)

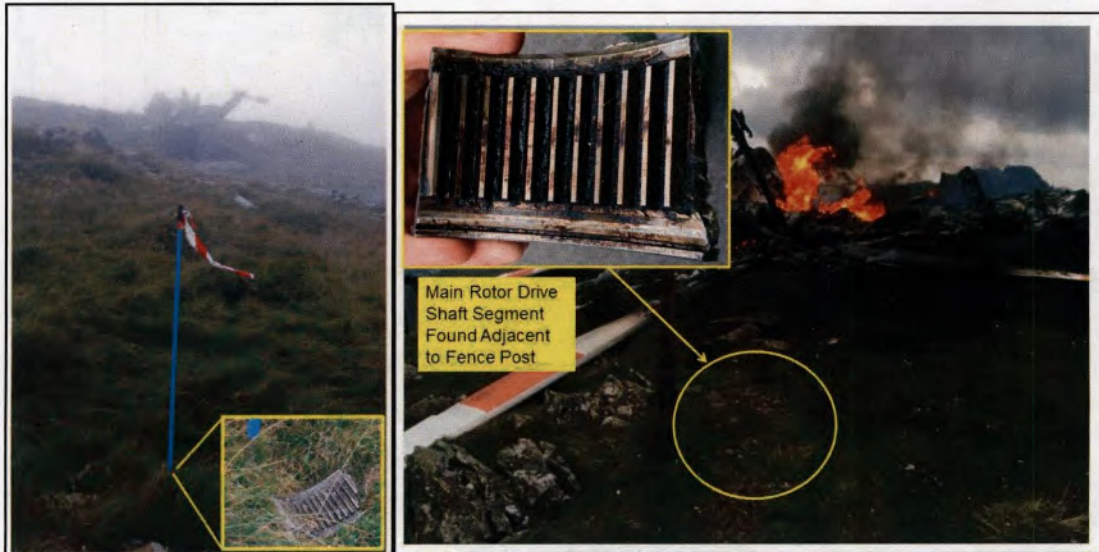
1.4.58. A number of aircraft components were found away from the central area of wreckage which were identified as of significant importance; these were 2 fragments of the driveshaft forward outer coupling (Figure 8) and 2 sections of yellow cowling (Figure 9).

Figure 8 - Forward outer coupling fragments found in relation to the aircraft wreckage.
(Picture Source: DAIB report)

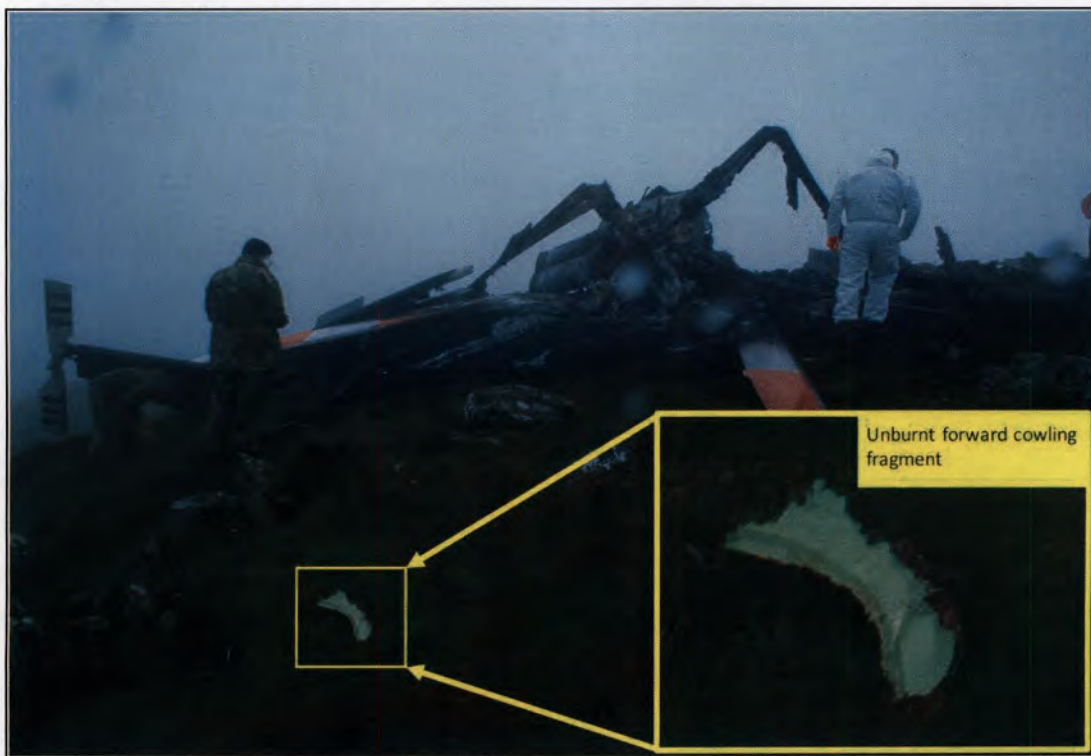
Figure 9 – One of the 2 fragments of aircraft cowling found to the rear right of the wreckage.
(Picture Source: DAIB report)

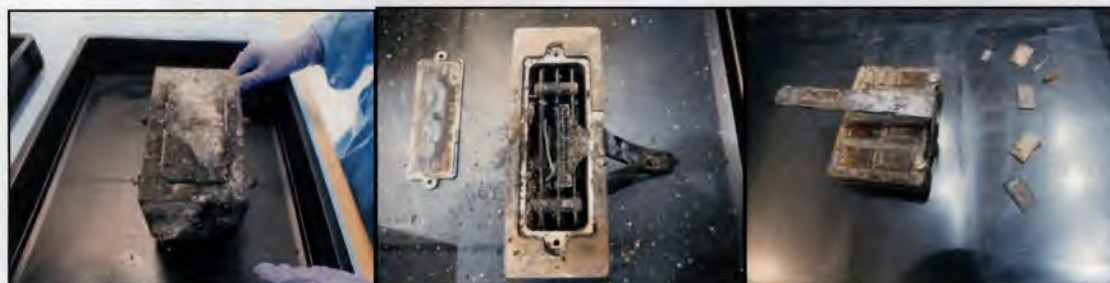
Figure 12 – [Left] CVR condition on recovery. [Centre] Memory module assembly. [Right] Three layer integrated circuit board and loose components.

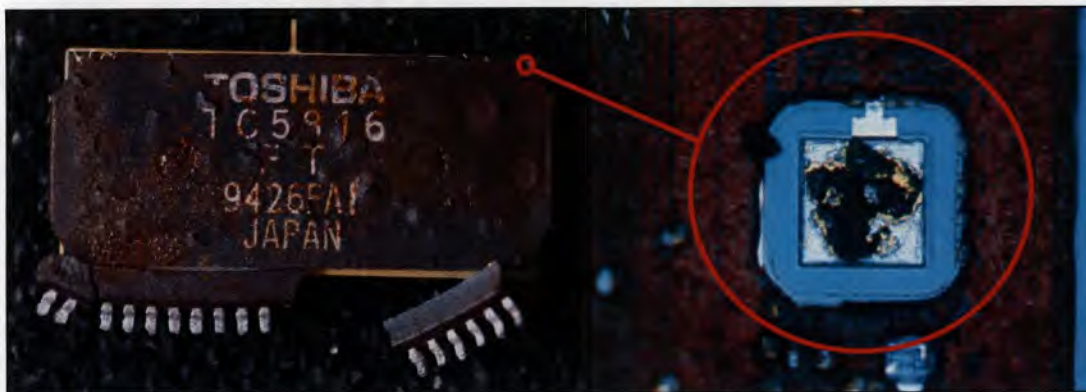
Figure 13 – [Left] Showing one of the damaged chips with partially de-packaged casing after recovery action and [Right] Showing a high magnification image of a damaged bond pad.
(Picture Source: DSTL Chip Damage Analysis Report.)

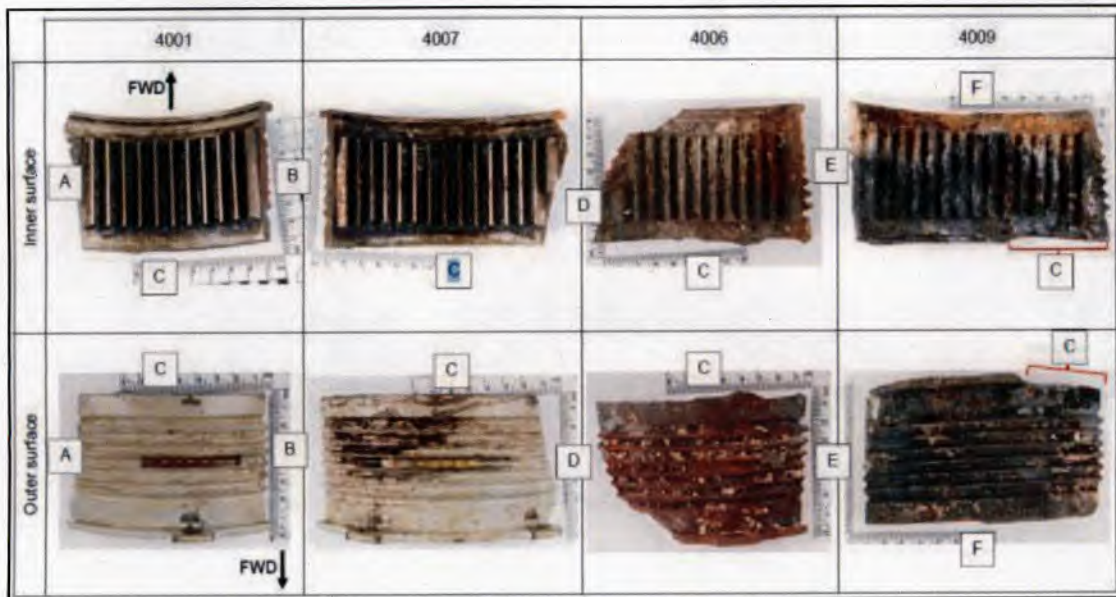
**Figure 20 - The forward outer coupling as recovered from the accident site. The axial fracture surfaces are labelled (A,B,D and E) and the circumferential flange failures on the aft face (C) and the forward face (F).
(Picture Source: 1710 NAS)**

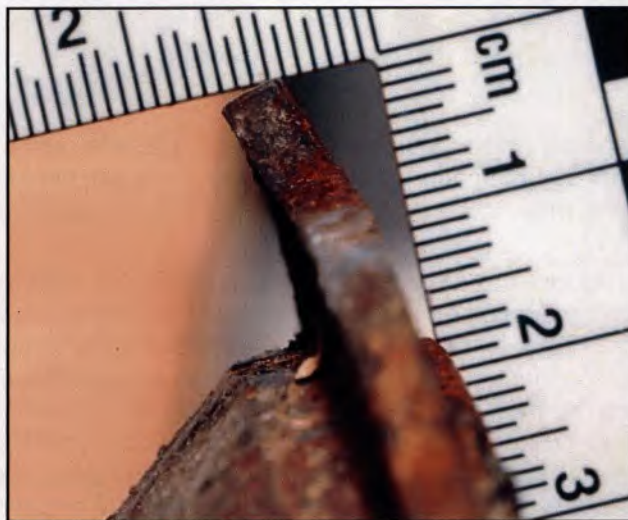
Figure 22 - Evidence of deformation of the main gearbox input adaptor flange.
(Picture Source: 1710 NAS)

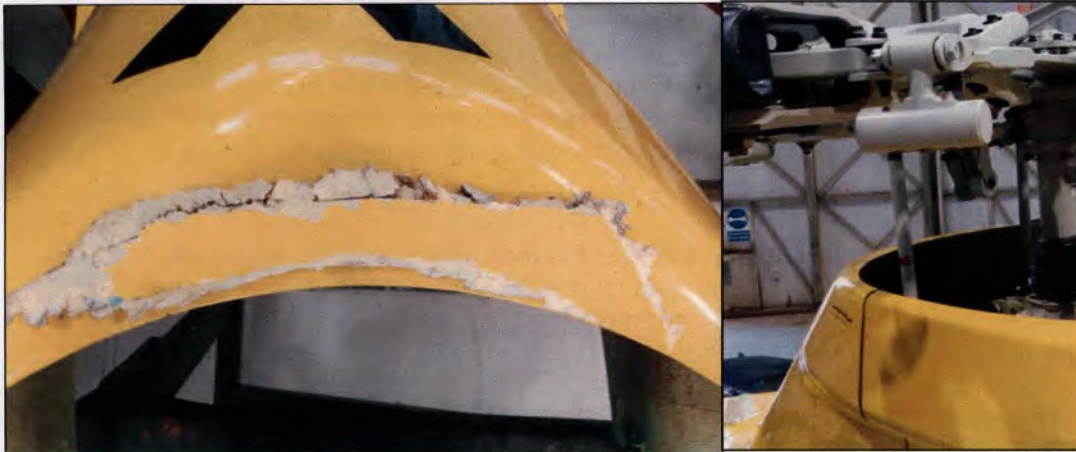
the main gearbox had moved forward during the accident.

Figure 24 – [Left] Cowling debris shown from above, overlaid on a serviceable component. [Right] Showing the relative position of the pitch change links to the cowling.
(Picture Source: DAIB Engineering)

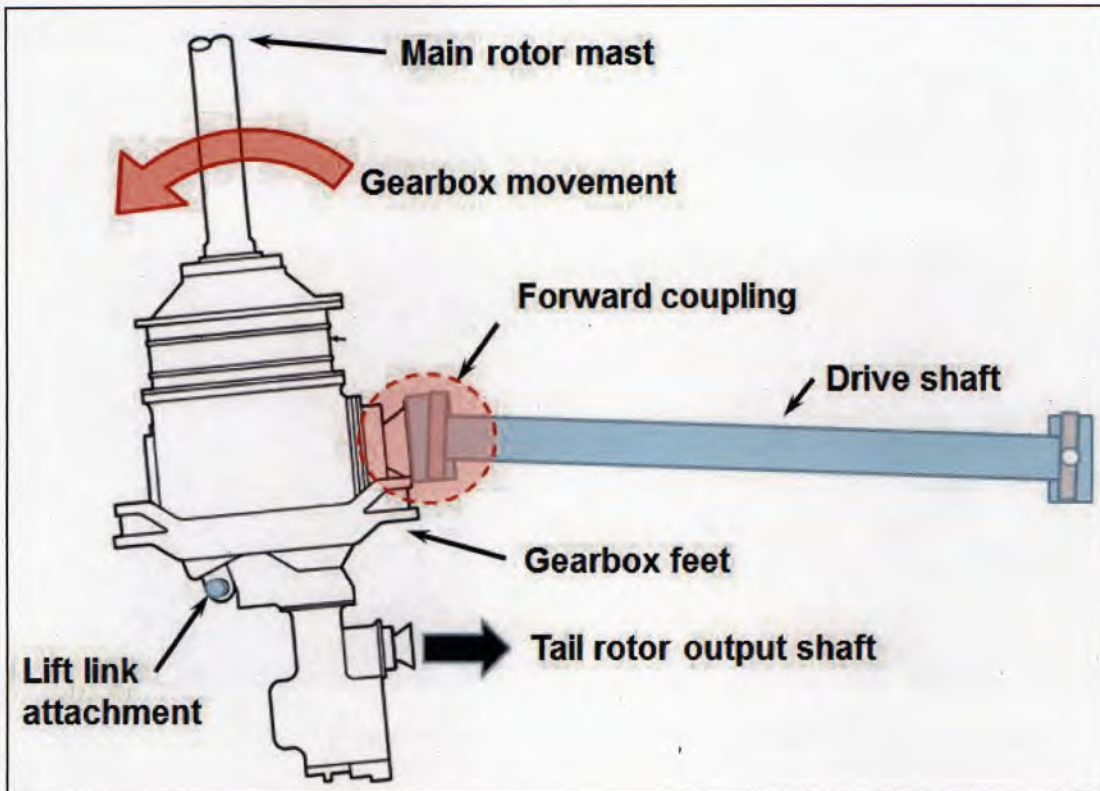
1.4.101. **Summary of main gearbox movement.** The main gearbox moved by an amount greater than 7.5° of misalignment at the forward outer coupling causing it to fail. Forward movement by this amount also caused consequential damage as the pitch change links cut through the forward upper cowling by 110 mm. The Panel concluded that the main gearbox moved forward during the accident by an amount greater than during normal operation. The Panel then sought to determine the cause of excessive main gearbox movement.

Figure 27 - Diagram showing gearbox movement and coupling misalignment.

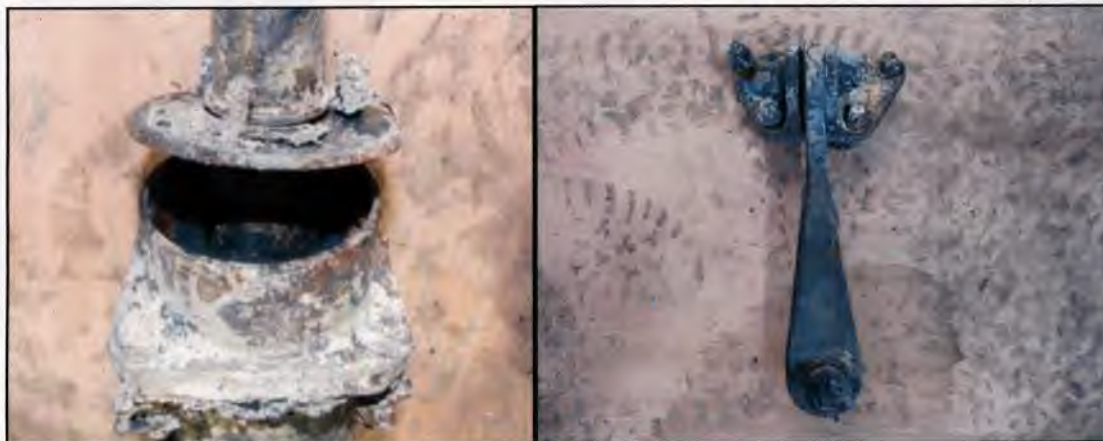
Figure 28 - Fire damaged corner mount and lift link assembly.
(Picture Source: Bell Factual Observations Report ZJ241)

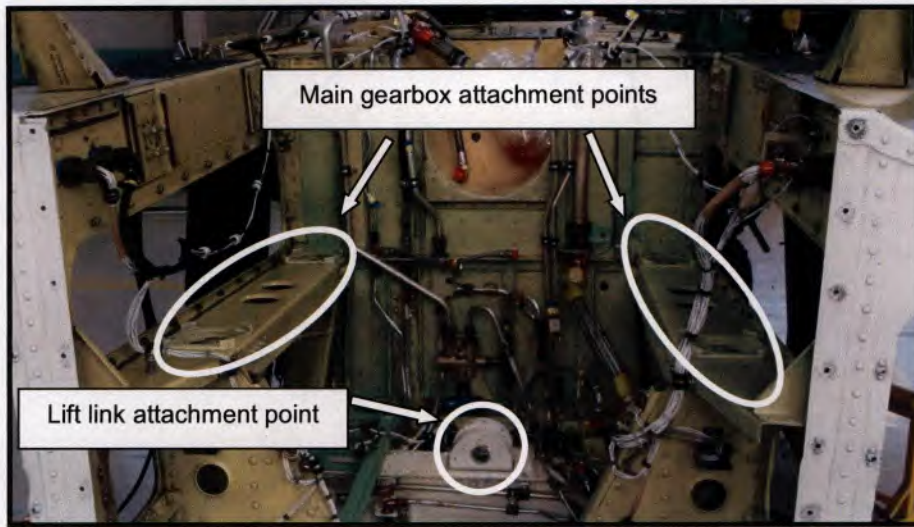
the attachment points. Airframe failure was **not a factor** in the accident.

Figure 29 – View of the airframe structure and attachment points to the gearbox, view looking forwards.

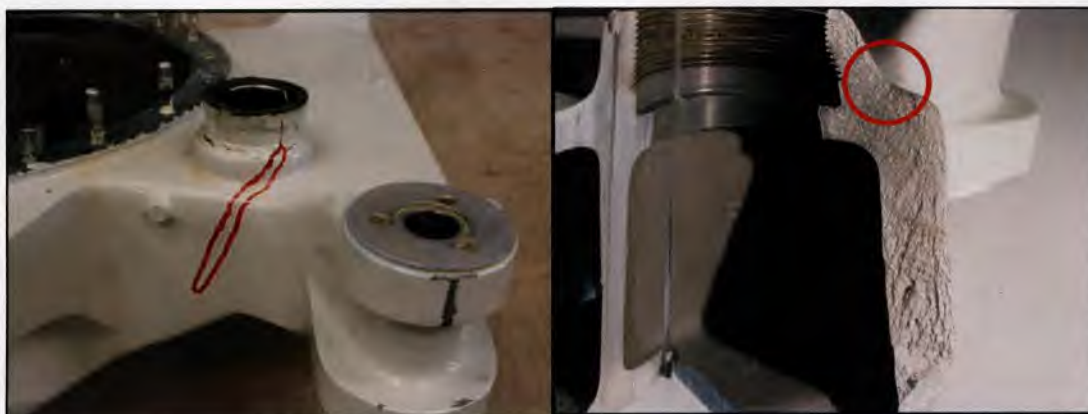
Figure 32 – Images from the Bell engineering laboratory report on the fatigue crack found within the support case of ZJ241 in 2006. [Left] Location of the fatigue crack on the support case. [Right] Fatigue crack surface showing the initiation site in the circle.
(Picture Source: Bell)

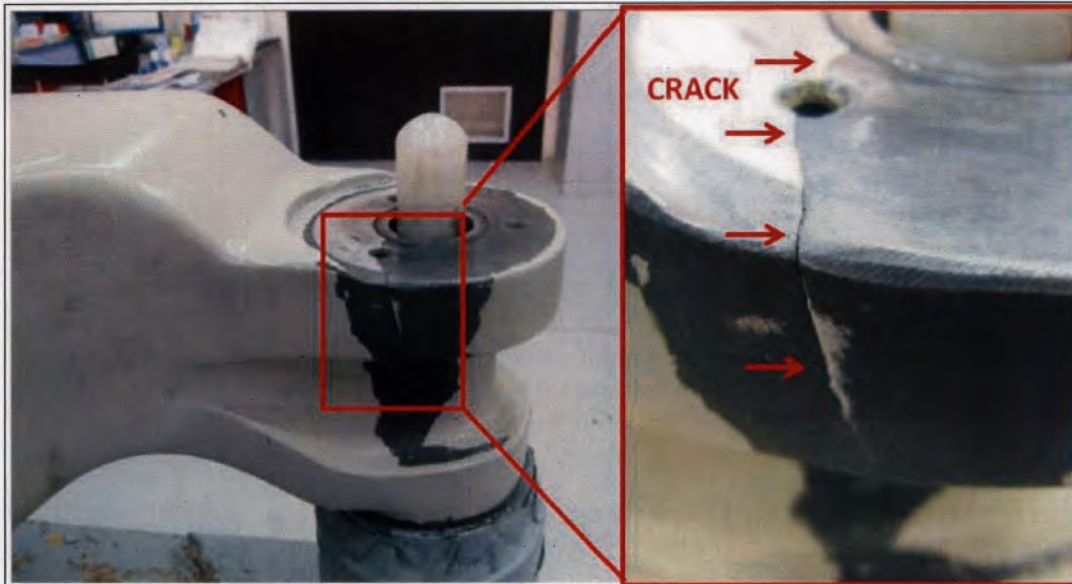
released in order to help with the investigation. Bell provided an example of a support case crack in an attachment leg that was identified prior to failure by the use of a HUMS regime. The cause of the crack was not possible to determine but Bell stated that it may have been due to incorrect assembly of the upper and lower main gearbox cases during depth maintenance. The crack was found on the attachment leg at the rear left gearbox mount (Figure 33).

Figure 33 – HUMS support case crack (2012).
(Picture Source: Bell)

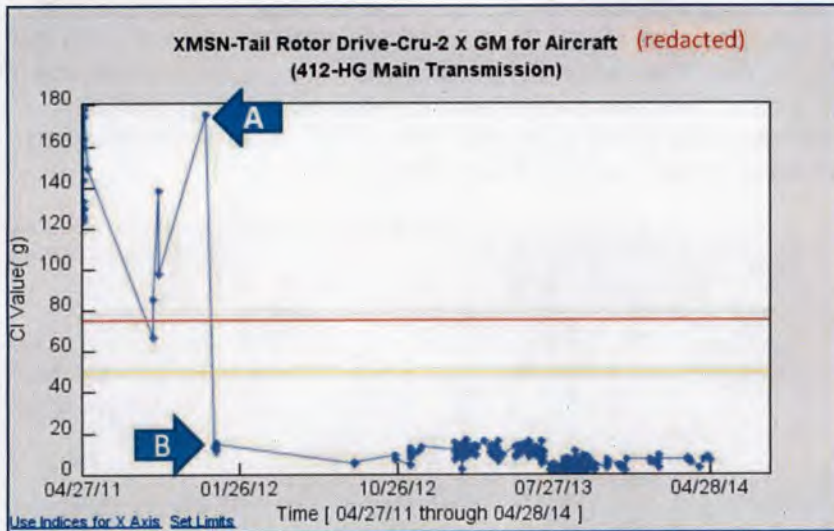
e. In the 2012 example, HUMS accelerometers detected unusually high levels of vibration. The level of vibration was undetected by the operator for at least 8 months and although it was unclear how many hours were flown during this period, none of the crew flying the aircraft detected anything unusual. It was brought to the operator's attention by Bell on review of the HUMS data. When the suspect support case was replaced by the operator, the level of vibration immediately reduced to below the acceptable threshold, confirming that HUMS had correctly identified an issue that led to the discovery of a fatigue crack in the support case (Figure 34 point A and point B).

Figure 34 - Hums data for the support case fatigue crack detected in 2012, showing significant decrease in vibration levels between point A and B after replacing the support case with a new component. The red line indicates a threshold level of vibration.
(Picture Source: Bell)

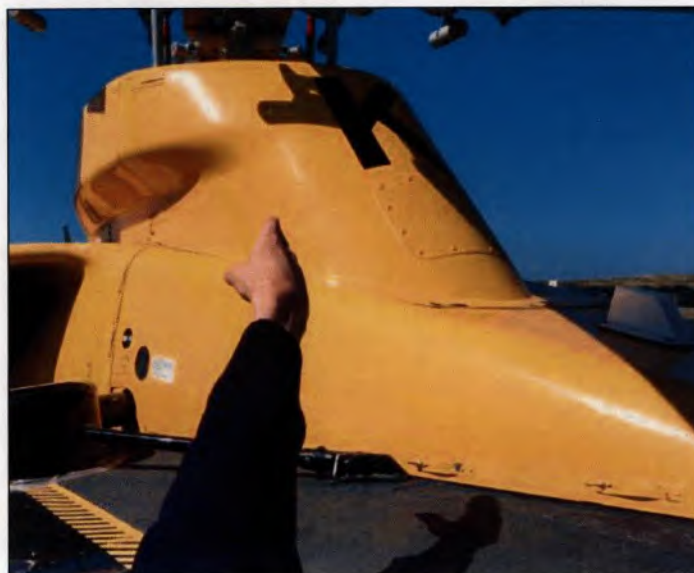
that the engine fire and emergency shut down drills were not fully completed and consequently the aircraft power supply and fuel booster pumps were left on. The Crewman Instructor attempted to fight the fire at the top of the rotor mast cowling by leaning out of the starboard cabin door with the aircraft fitted fire extinguisher, however there was no impact on the fire (Figure 41).

Figure 41 – Approximate location of the fire and Crewman Instructor's view while discharging the fire extinguisher.
(Picture Source: Crewman Instructor)

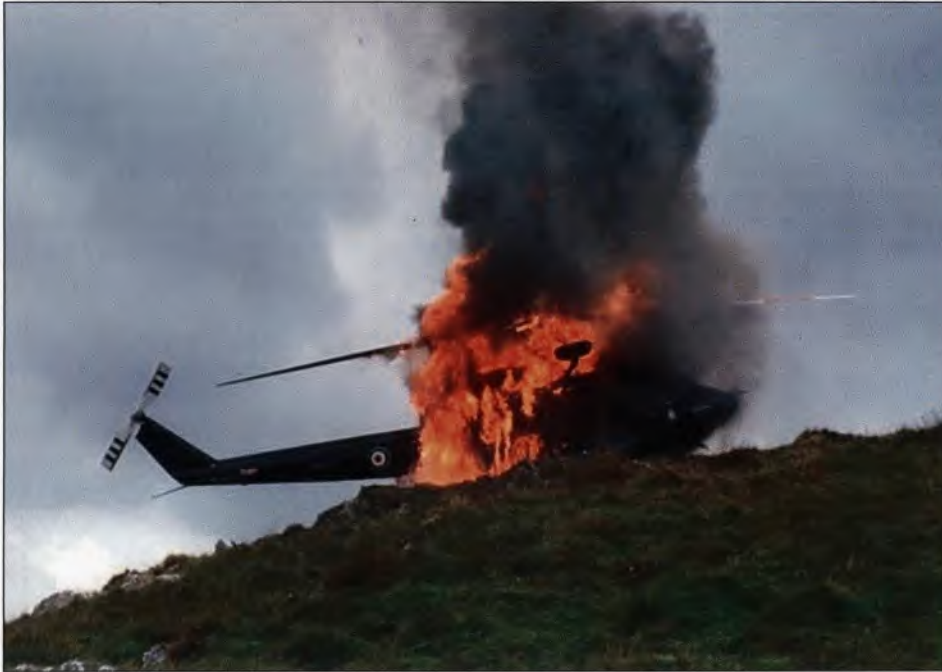
Figure 42 - Aircraft fire approximately 5 minutes after the accident.
(Picture Source: Aircraft Commander A)

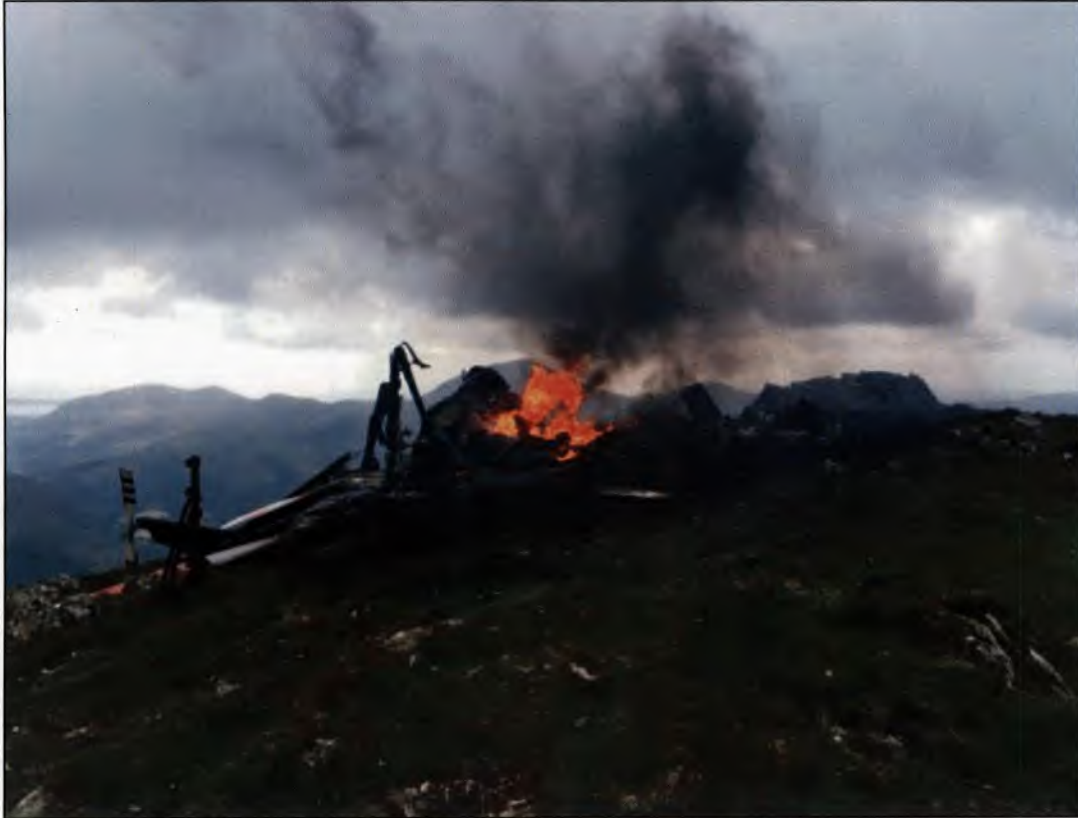
Figure 44 – Fire approximately one hour after the incident
(Picture Source: Passenger)
