Defence
Safety
Authority

Service Inquiry

HAWK T Mk1A XX204

SERVICE INQUIRY INVESTIGATION INTO ACCIDENT INVOLVING HAWK T MK1A XX204 AT RAF VALLEY ON 20 MAR 18

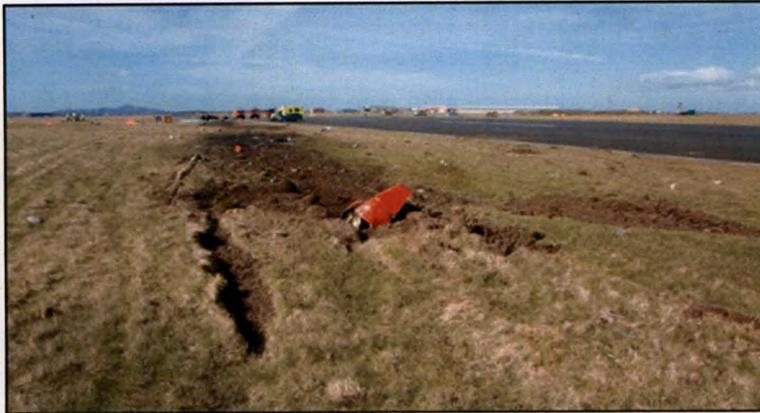
Figure 1.3.3 - XX204 Initial impact point

1.3.10. The initial point of impact, as shown in Figure 1.3.3, was approximately 247 m from the runway threshold and 40 m to the left of the runway centreline. During the impact sequence, the aircraft caught fire and the fuselage and wing separated; the fuselage rolled onto its left side before coming to rest in an upright position orientated in the reciprocal direction to the approach path 187 m from the initial impact. There was substantial structural damage to the forward part of the fuselage and a severe fire around the cockpit area. The aircraft wreckage was spread over an area approximately 50 m wide by 200 m long. The fuselage and wing were located within 15 m of each other with scattered wreckage filling the rest of the area.

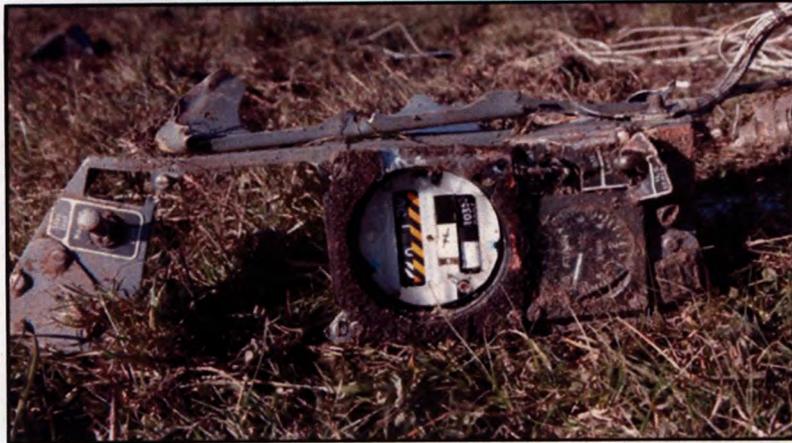
Figure 1.4.3 - XX204 front cockpit main altimeter as located at crash site

1.4.136. Due to XX204's height parameters during the PEFATO sequence, and anomalies identified with the ADR height data, the Panel sought to establish, as far as was reasonably possible, whether R3 had set an incorrect pressure setting.

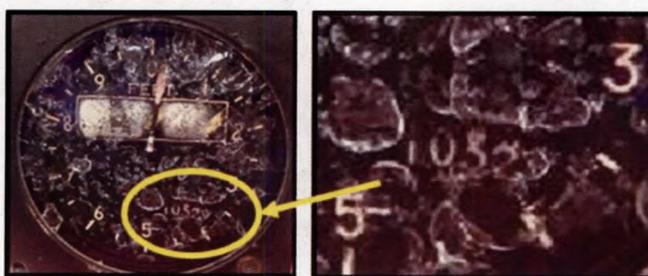
Figure 1.4.5 - XX204's rear cockpit main altimeter

1.4.138. R3 did not recall checking his altimeter prior to take-off but, in the Panel's experience, it is very likely that R3 would have completed runway line-up checks that included checking the altimeter. In the Panel's opinion, based on R3's experience as a QFI and his actions during the transit sortie, it was extremely likely that R3 had directed the engineer to set the appropriate pressure setting during start up, and therefore judged that it was more likely than not that R3 would have set 1032 hPa on his own instruments. Consequently, the Panel concluded that R3 flew the PEFATO profile on the correct pressure setting and therefore was **Not a Factor**.

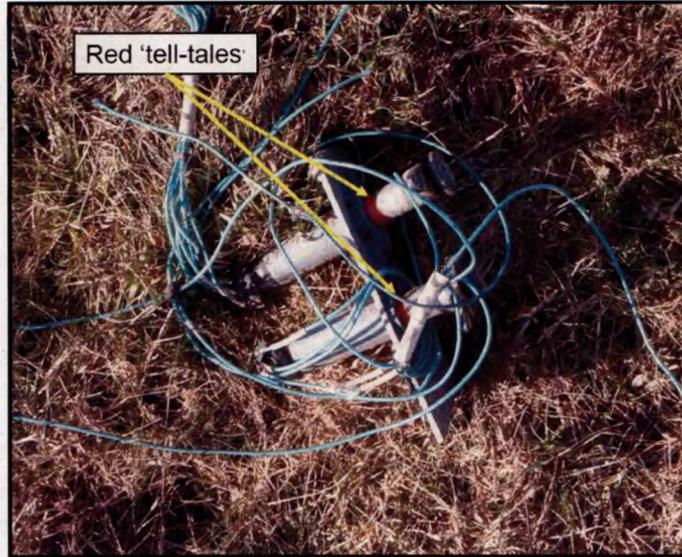
Figure 1.4.18 - XX204's Undercarriage and flap emergency lowering selectors

1.4.335. Although the flap and landing gear systems were observed in the down configuration, the method of operation was unclear as the standby lowering selectors were recovered¹³⁵ with the red tell-tale bands visible, indicating that they had been activated, as shown in Figure 1.4.18.

1.4.336. In-depth technical analysis¹³⁶ assessed the level of damage to the switches to be minimal; it was judged that their operation by force would have led to much greater damage both to the switches and the adjacent components. Assessment of the explosive start valves that initiated the standby systems determined that they were free from explosives, but it was not possible to determine if this was due to manual initiation or as part of the accident sequence and subsequent fire.

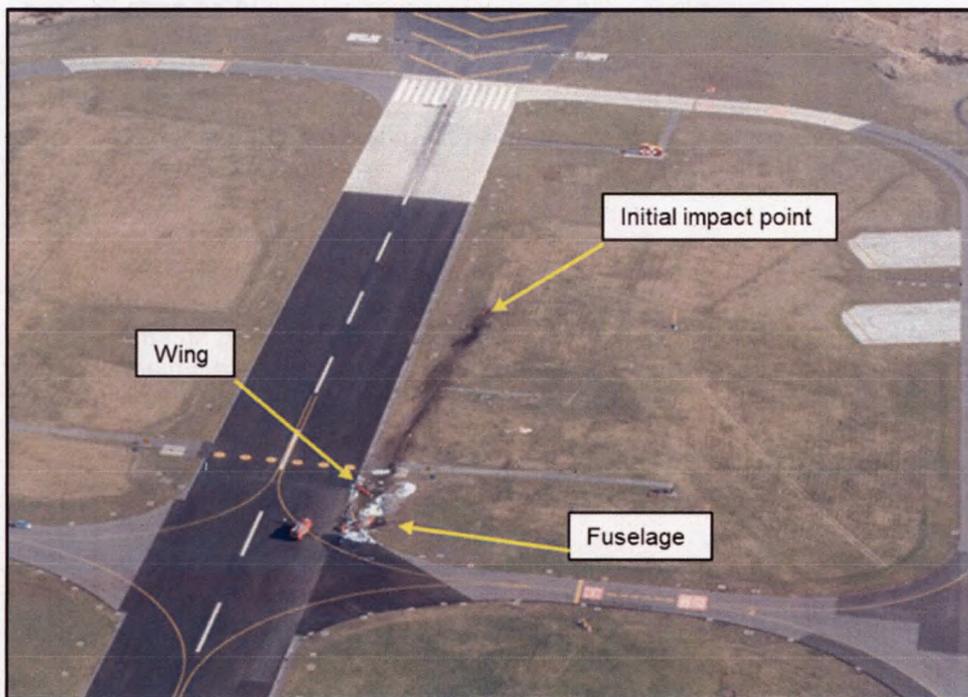
Figure 1.4.19 - Overview of crash site

1.4.366. The aircraft impacted the ground approximately 15° right-wing low with an essentially level pitch attitude and at 151 kts; the initial point of impact was 247 m from the runway threshold and 40 m to the left of the runway centreline. The aircraft wreckage was spread over an area approximately 50 m wide by 200 m long. The fuselage and wing were located within 15 m of each other with scattered wreckage filling the rest of the area. An overview of the crash site is shown in Figure 1.4.19.

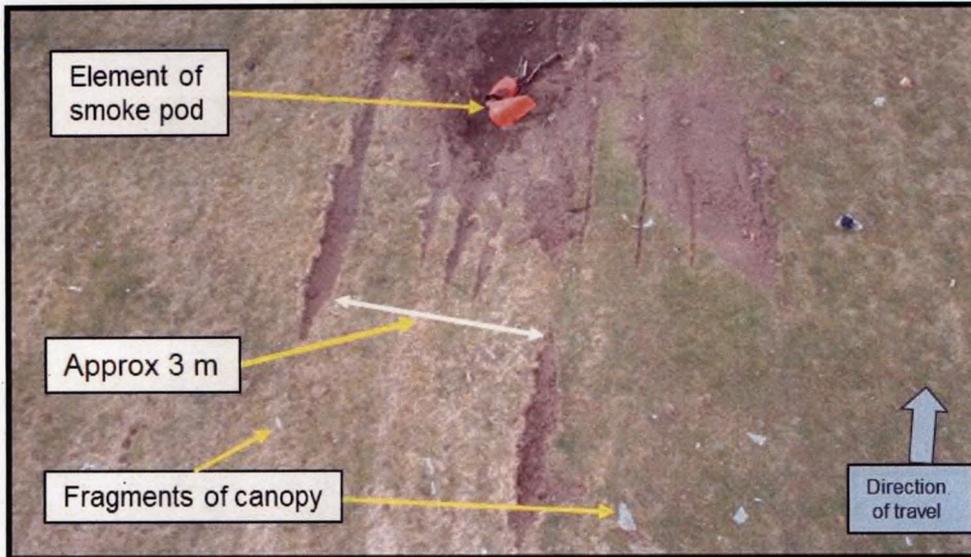
Figure 1.4.20 - Initial impact point

1.4.367. The initial impact point contained parts of the smoke pod. Fragments of the aircraft canopy transparency and Miniature Detonation Cord were scattered before the impact point, the proximity of which indicated how close to impact the ejection occurred. The initial impact point is shown in Figure 1.4.20.

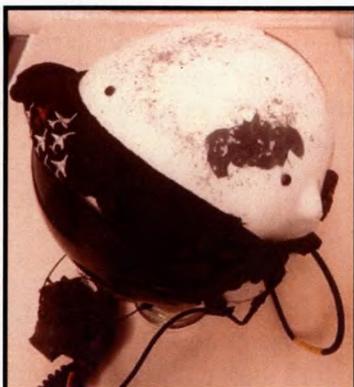
Figure 1.4.23 - R3's aircrew helmet

1.4.378. The Panel were unable to categorically establish how R3 landed but the balance of the evidence¹⁵¹ indicated that the most likely cause for [REDACTED], was that his head impacted the ground during the parachute landing.
