SERVICE INQUIRY INTO AN AIRCRAFT ACCIDENT

DATE	02 July 2009		LOCATION AND GRID REFERENCE	GLEN KINGLAS, ARGYLL, SCOTLAND N 56 14 58 W 004 52 15 (D M S) 222228.378 N710035.602 (National Grid)		
AIRCRAFT TYPE		MARK	SERIAL NUMBER		PARENT UNIT	
TORNADO		F3	ZE982		RAF LEUCHARS	
NAMES OF CREW		(Pilot) Flt Lt Thompson, Kenneth Alistair Louvin		PARENT UNIT	RAF LEUCHARS	
		(Navigator) Flt Lt Morton, Nigel David			RAF LEUCHARS	
NUMBER OF CASUALTIES						
KILLED			INJURED			
CREW	PASSENGERS	OTHER	CREW	PASSENGERS	OTHERS	
2	0	0	0	0	0

SERVICE INQUIRY INVESTIGATING THE ACCIDENT TO TORNADO F3 ZE982
ON 02 JUL 09

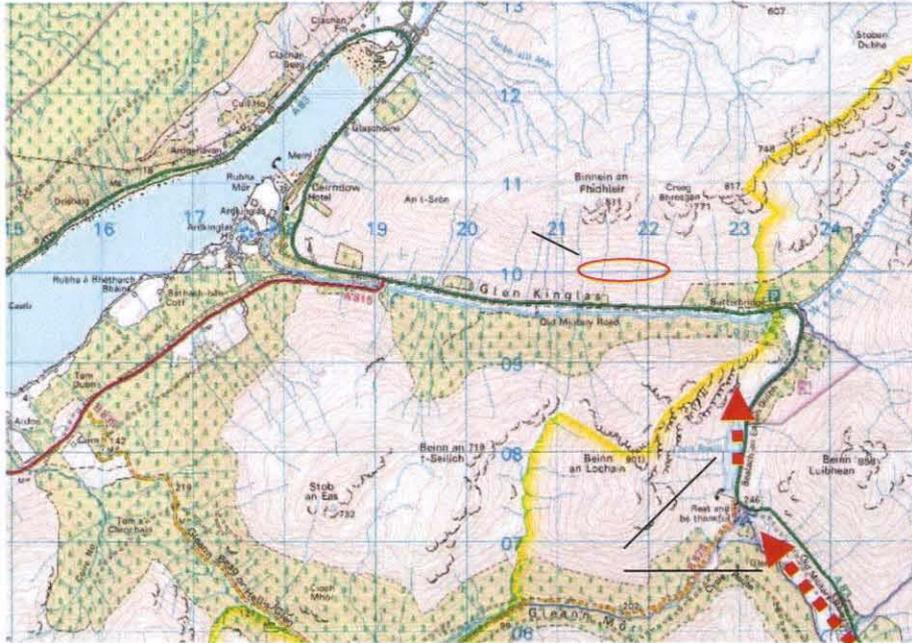
Figure 1
Accident Location

a. The initial impact point was N 56 14 58 W 004 52 15 (D M S) 222228.378 N710035.602 (National Grid), 1198ft AMSL on the north slope of GLEN KINGLAS, SCOTLAND. The Glen is approximately 37 miles north-north west of Glasgow and runs east-west. The A83 road and RIVER KINGLAS run along its floor and the Glen has steep sides with numerous burns running down the hillside in ravines. Figure 1 shows the direction of approach from the south-east with the crash site circled.

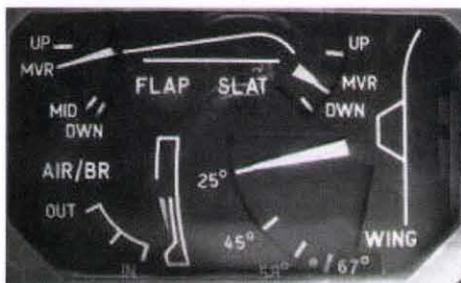
Figure 6

16. Following confirmation of the ac configuration at impact, the Panel considered the possibility of a temporary restriction within the wing sweep mechanism or both an unserviceable and/or misread Cockpit Position Indicator (CPI) as factors. Investigation into the CPI found that the graduation movement of the wing sweep indicator from 25° to 27.9° was small. A slight gauge discrepancy could easily be interpreted as the wings being fully forward (25°). With the wings fully forward (25°) the selection of MVR would have provided a flap and slat indication on the CPI as shown in Figure 6. With the wings at 27.9°, only the MVR slats would travel (Figure 7). Additionally, slat deployment could easily be confirmed visually on the leading-edge of the wing (though the flap would not have been visible). At MVR selection, the gauge movement for the flaps on the CPI is less than that of slat. The calibration of ZE982's CPI could not be proven post the accident. The final recorded check of the wing sweep was verbal by the Pilot and was carried out after selection, during a relatively benign phase of flight. The selection of MVR was carried out on entry to the series of valleys at TARBET, coincident with an increase in workload. The Panel could not rule out a combination of gauge error, gauge interpretation and/or temporary restriction as factors effecting the ac configuration at the time of the accident. Nonetheless, considering the weight of evidence, the Panel concluded that the final configuration was more likely to be as a result of mis-selection and subsequent gauge interpretation, rather than a technical event.

Exemplar 25° MVR Wing
