MAA DG/SI/01/11 SI ZG792

**SERVICE INQUIRY INVESTIGATING THE ACCIDENT TO TORNADO GR4 ZG792
ON 27 JAN 11**

**MILITARY AVIATION AUTHORITY
PROCEEDINGS OF A SERVICE INQUIRY
INTO AN AIRCRAFT ACCIDENT**

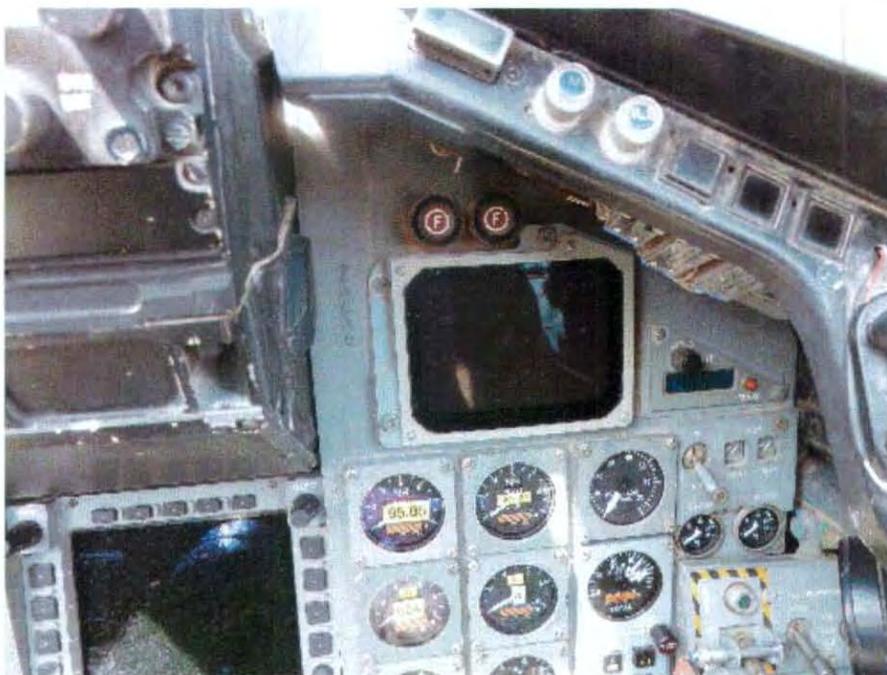
Figure 7 - Fire buttons on right side of cockpit

17. **GR4 cockpit ergonomics.** In his formal interview the pilot stated that he had pushed both fire buttons with his left hand. Given the position of the fire buttons (see Figure 7) this would have been an unnatural hand to have used. The LP cocks are positioned on the left side coaming of the cockpit, just below eye-level but both easily accessible and obvious (Figure 8). Had the pilot only operated the fire buttons the Panel believed it would have been more natural to have used his right hand (Figure 10). However, if his left hand was already available from having just closed the LP cock, the Panel reasoned that it would be understandable to use the same left hand to reach across and push the fire buttons (Figure 11, Figure 12). This would speed the process up and avoid the pilot having to swap hands on the control column. The fact that the pilot used his left hand to activate the fire buttons suggested that he may have previously used it to close the LP cock. Just prior to receiving the L FIRE caption, the pilot initiates a right hand turn. This action would have required a positive control input from him. Given that the Panel believe the pilot actioned the fire button press during the turn, it is also possible that he failed to close the LP cock but used his left hand as his right hand was occupied flying the ac. The HF report also alludes to the fact that this unnatural use of his left hand could have made the omission of the LP cock more likely, as his use of the left hand may have convinced him that the action was done. The Panel was unable to determine which of these sequences was correct.

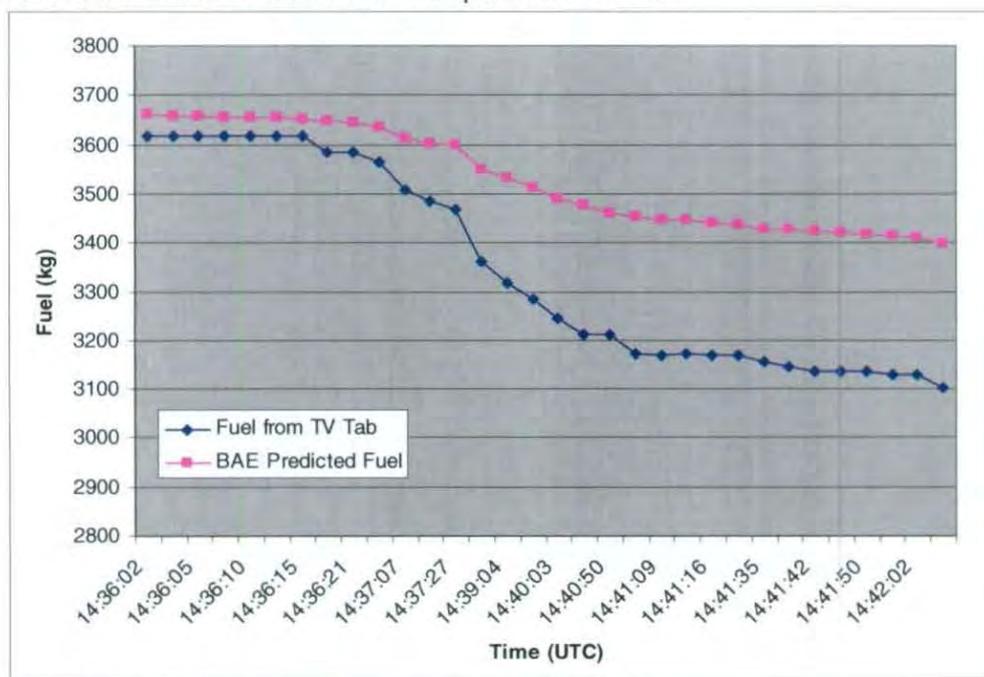
Figure 14 - BAE Systems Fuel Flow Rates

data, and provide their opinion as to the most likely sequence of events in order to determine when the LP cock was closed. Initially all the JPEG photos from the WSO's TV/Tab were re-checked by personnel not involved with the original collection of data. Again, data was only used if both a time and fuel figure could be derived from the snap shot; no interpolation was used. This check confirmed that the original figures used were correct. This information was provided to BAE Systems propulsion who spent 2 weeks independently reviewing the data. The department were provided with the fuel level figures and asked to plot them against BAE Systems predicted fuel flow rates. BAE Systems used their own models to calculate the predicted burn rates which are detailed in Annex J. These models allow for a greater degree of accuracy than the ODM as the models allow more specifics to be entered in calculating the exact fuel burn rate (of note the BAE Systems fuel flow rates closely matched the Panel's ODM rates). Figure 14 shows the BAE Systems plotted fuel flow rates. The Pink lines show the BAE Systems modelling of the fuel level and the blue line shows the actual fuel quantity as displayed on the WSOs TV/Tab. What can clearly be seen is a consistent divergence from the predicted fuel quantity set against the actual fuel quantity implying a leak. The lines become more parallel at approx T4:37, implying that at this stage the leak had reduced (and/or stopped) and as such the fuel to the engine had been isolated. This graph supports the theory that the fuel was not isolated until much later on in the emergency. After the graph had been produced BAE Systems were asked to comment on the likely cause of this leak and the conclusions from MilAAIB. BAE Systems concurred with the analysis from MilAAIB and stated that they believed that the LP cock was left open until T4:37.
