Service Inquiry

Griffin HT Mk1
ZJ241, Snowdonia

09 August 2016

SERVICE INQUIRY INTO THE ACCIDENT INVOLVING A GRIFFIN MK1 ZJ241 AT YR ARAN, SNOWDONIA, WALES ON 9 AUG 16

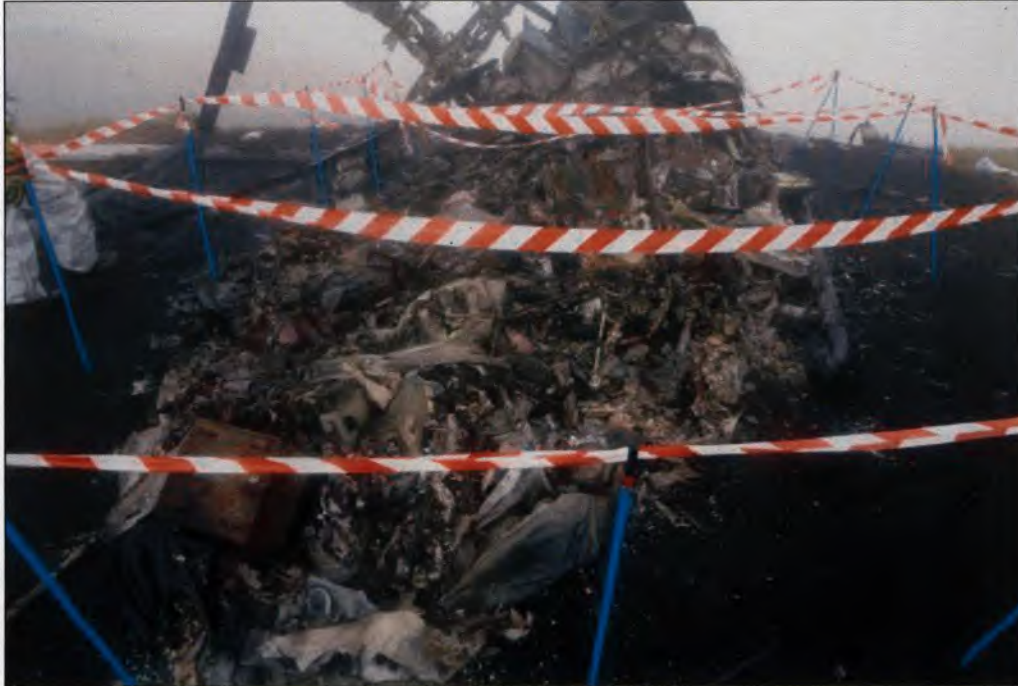
due to the remote location. Personnel from JARTS worked under the direction of the DAIB Engineering Investigators to cut the wreckage down to a size, shape and weight to enable relocation of the wreckage via underslung load. The remainder of the smaller components of the aircraft were collected into bags and labelled by location. The wreckage was ultimately relocated to MOD Boscombe Down.

Figure 6 - Aircraft wreckage recovery.
(Picture Source: DAIB Engineering)

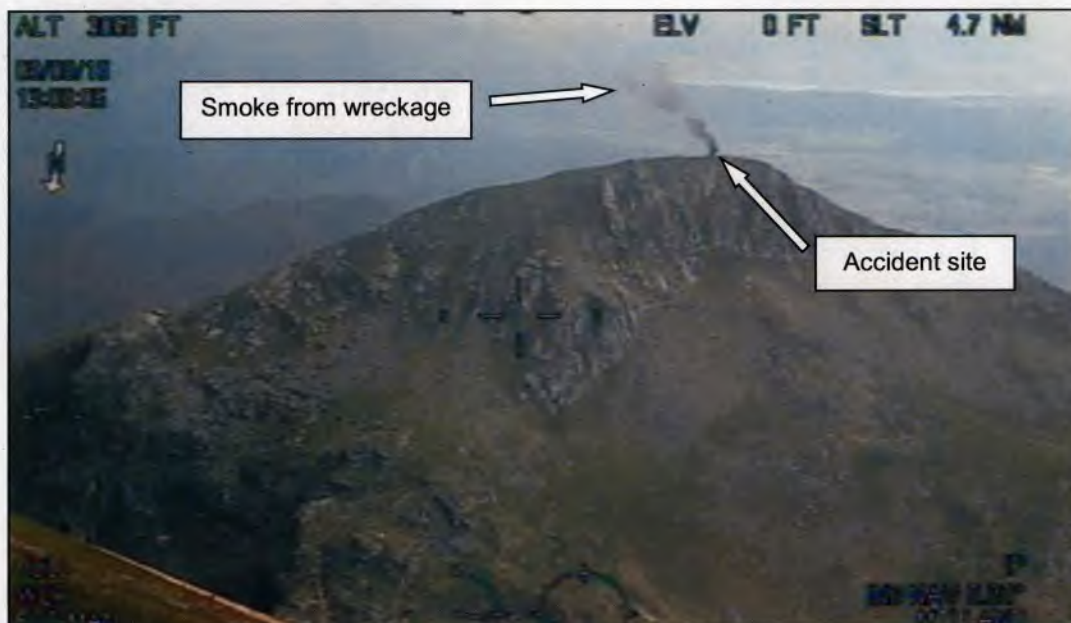
1.4.55. **Accident site.** The aircraft wreckage had been removed from the hillside prior to the Panel's arrival due to the degrading environmental conditions and the need to preserve the evidence. Any immediately obvious and perishable evidence was retrieved by DAIB investigators who had been on-site for the preceding days. Other than witness accounts and photographs, evidence from the accident site initially provided the basis for the Panel's consideration. The accident site was situated on the summit of the mountain which was the shape of a hump-back ridgeline orientated north-east to south-west with a steep, rocky, north-west face. A picture of the mountain was taken by a rescue aircraft, 30 minutes after the accident, (Figure 4).

Figure 4 - Yr Aran viewed from the north.
(Picture Source: Maritime and Coastguard Agency)

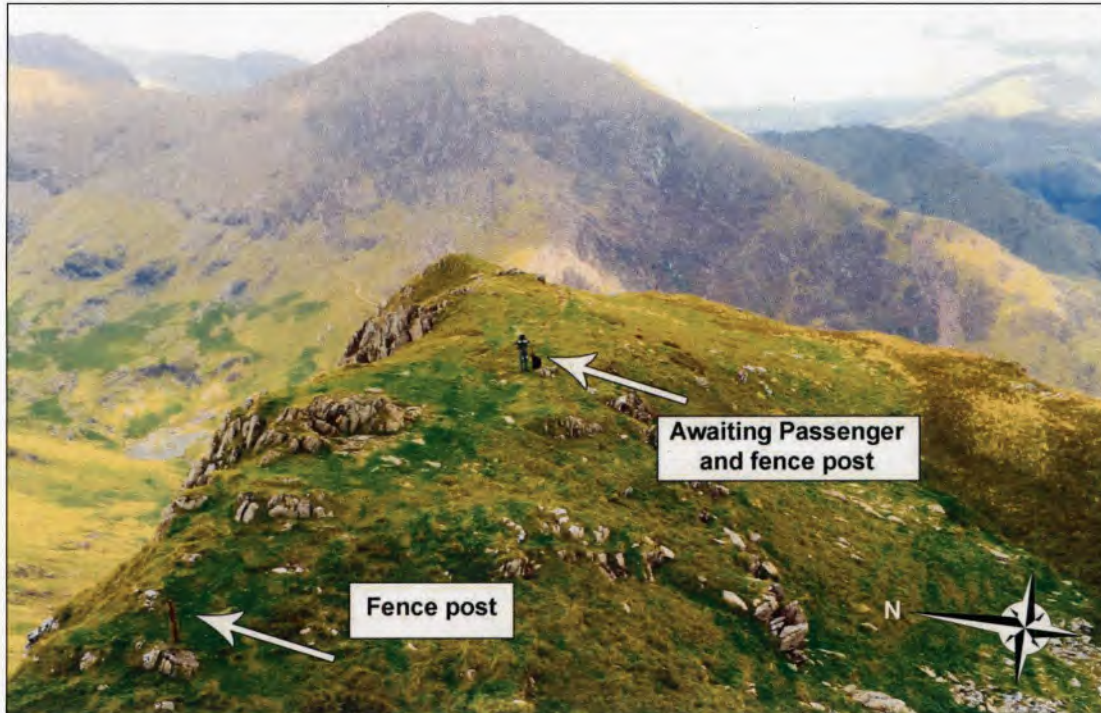
1.4.56. The top of the mountain was mostly grass, interspersed with rocky outcrops and embedded smaller rocks within the vegetation. A number of rusty fence posts protruded but no longer had the original horizontal wires. The top was relatively flat but became steeper further away from the summit, except for one area of flatter ground to the south of the summit. An indistinct walker's path extended along the top of the ridgeline. A photo of the landing site was taken from the right hand cabin door on the final approach showing the position of the Passenger next to one of the fence posts (Figure 5).

Figure 5 – Landing site, fence post and Passenger approximately 2 minutes before the accident.

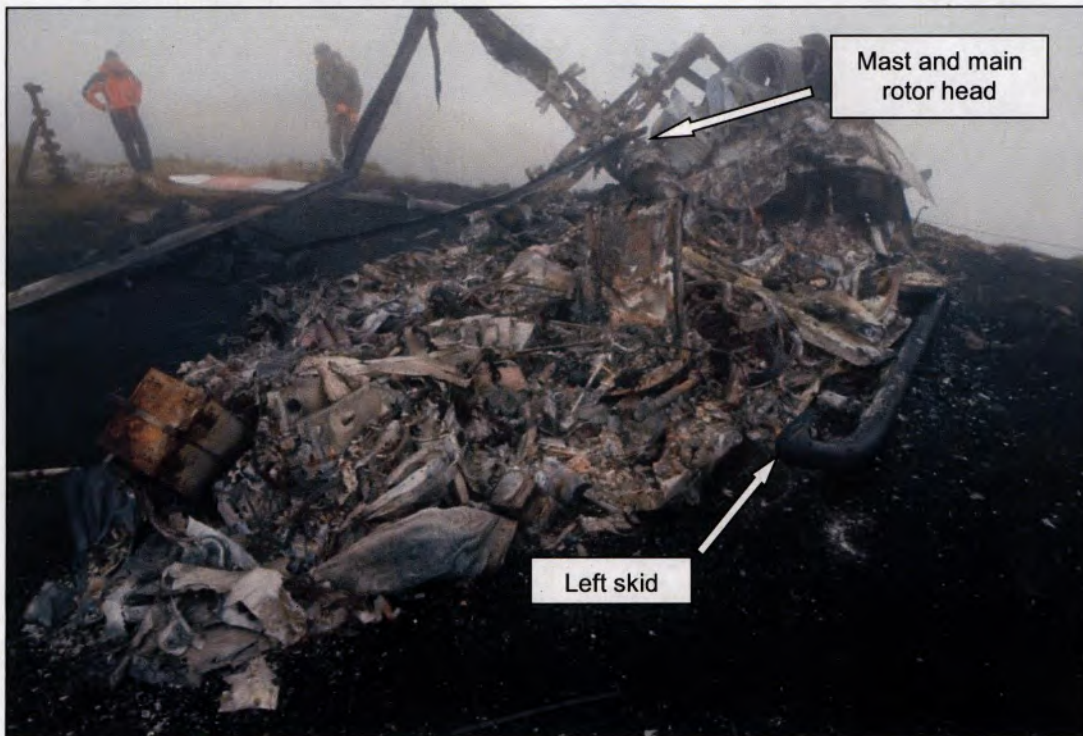
1.4.57. The aircraft wreckage was located just below the top of the ridgeline, adjacent to a small rocky outcrop in the 10 o'clock position of the aircraft and a fence post in the 3 o'clock position on the right hand side of the aircraft (Figure 6). The aircraft remains were in one location with the main components relatively contained in the immediate surrounding area (Figure 7).

Figure 7 - Aircraft wreckage and immediate surrounding area.
(Picture Source: DAIB Engineering)

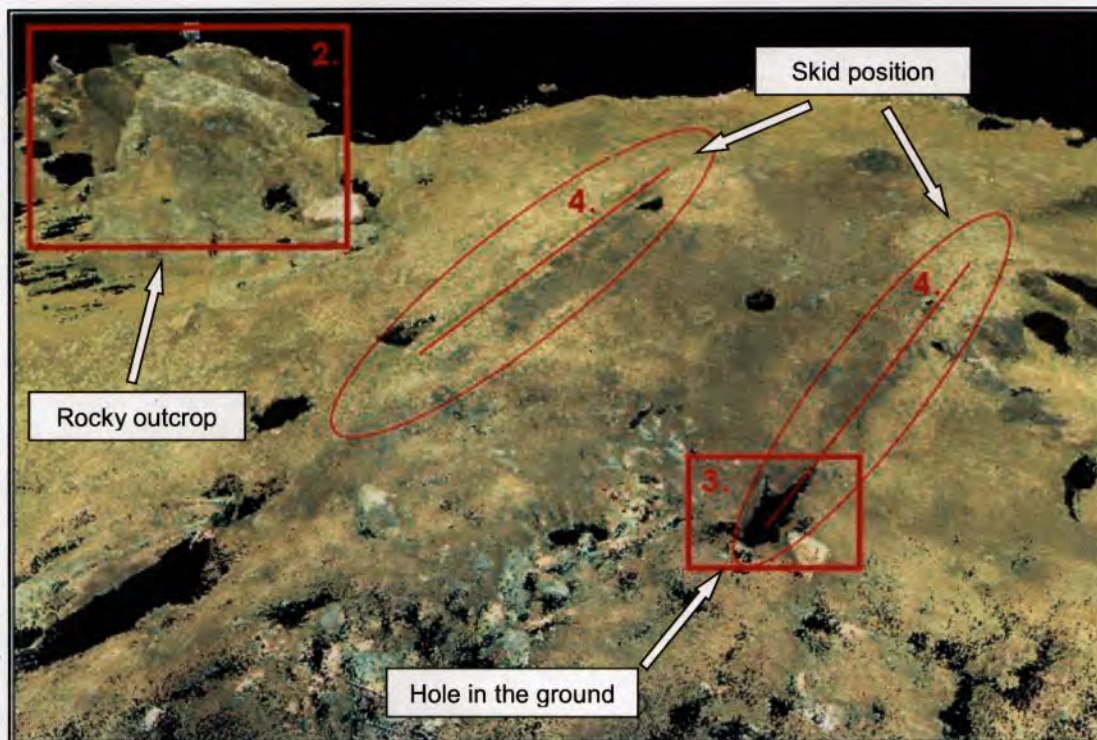
Figure 10 - Geographic survey of the accident site.
(Picture Source: 42 Engr Regt (Geo))

1.4.60. **Final resting position.** Through identification of the skid position (Figure 10, Number 4) and comparison with the computer model and geographic survey data, the final resting position of the aircraft was assessed. The LIDAR and photographic data showed roughly parallel lines close to the inter-skid distance. The rear of the right skid was found 'dug in' to the ground, such that it was prevented from moving further down the slope creating a small hole (Figure 10, Number 3). This hole contained rocks and some melt material that was removed during the site clearance, along with other surface materials, soil, stones etc. Therefore, the full cause and extent of the surface markings was not clear and consideration of the LIDAR plot accommodated all these factors when assessing the shape and angle of the pre-accident slope. The subsequent slope analysis provided the final resting position skid slope angles (Table 2).

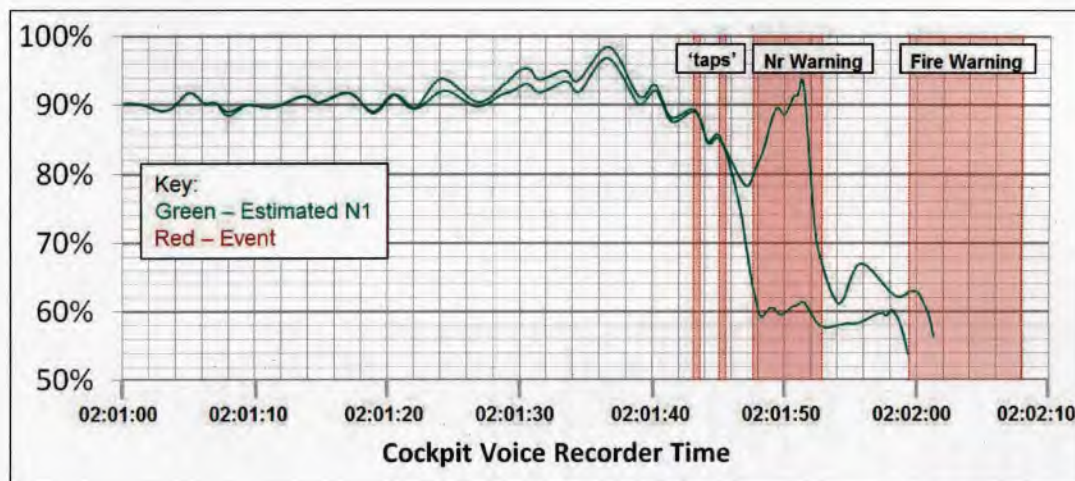
Figure 15 – Chart showing DAIB estimate of engine speed and other events derived from the spectrograms.

1.4.70. DAIB used the spectrograms to analyse engine speeds and other events during the accident and estimated that there was a peak in engine speed during the approach to land. DAIB’s technical analysis of the engines in conjunction with a physical inspection by Pratt and Whitney concluded that the engines were responding to demands and operating correctly and within limits during the accident. Other events that were visible on the spectrogram were: a series of ‘taps’, audio warnings, a split in engine speed and engine shut down. The Panel then focused its analysis on the information that was audible on the CVR and recorded on the transcript.

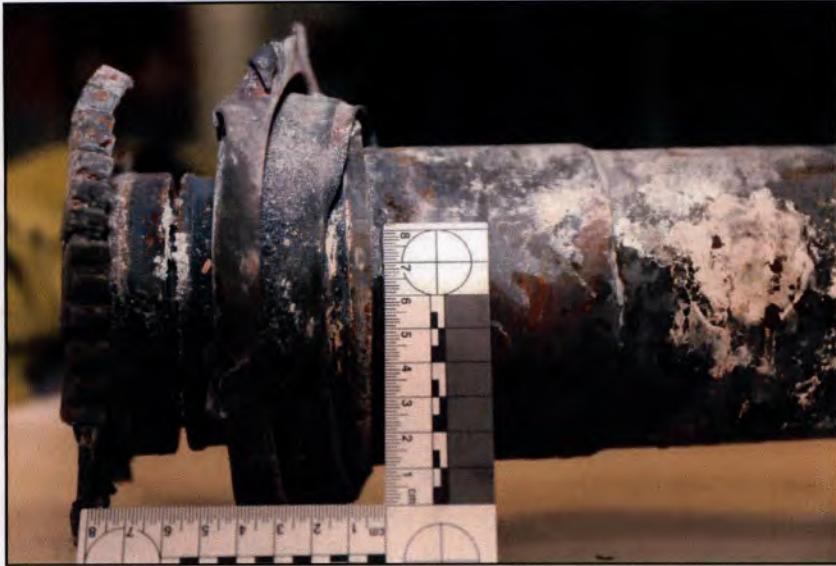
1.4.87. **Forward inner coupling.** Forensic analysis by 1710 NAS determined that, “The forward inner coupling was fractured with chunks missing, cracked, bent and the splines chipped” (Figure 21). The fracture surfaces contained evidence of ductile overload caused by bending of the inner coupling. The chipped splines were consistent with impact during rotation of the shaft in a geometric lock due to a misalignment. This damage indicated that the inner coupling imparted an abnormal load on the outer coupling, resulting in the bursting of the outer coupling due to an overload failure at high strain rate.²⁰ The 1710 NAS report detailed that this action would have occurred very quickly and in the manner of an explosion, which explained the trajectory and final resting position of the outer coupling fragments. Despite not being able to analyse all the fracture surfaces in detail, enough evidence existed for 1710 NAS to conclude that the forward outer coupling failed through overload rather than fatigue and that this was consequential rather than causal. It was also determined that the cause of misalignment was due to an event forward of the coupling. This was supported by evidence that the inner coupling was found distorted at the forward end and that there was significantly less damage at the aft end of the shaft. The forward outer coupling was attached to the main gearbox input adaptor and it was therefore necessary to analyse this further to understand the cause of the misalignment.

Figure 21 - Forward inner coupling including oil boot.
(Picture Source: 1710 NAS)

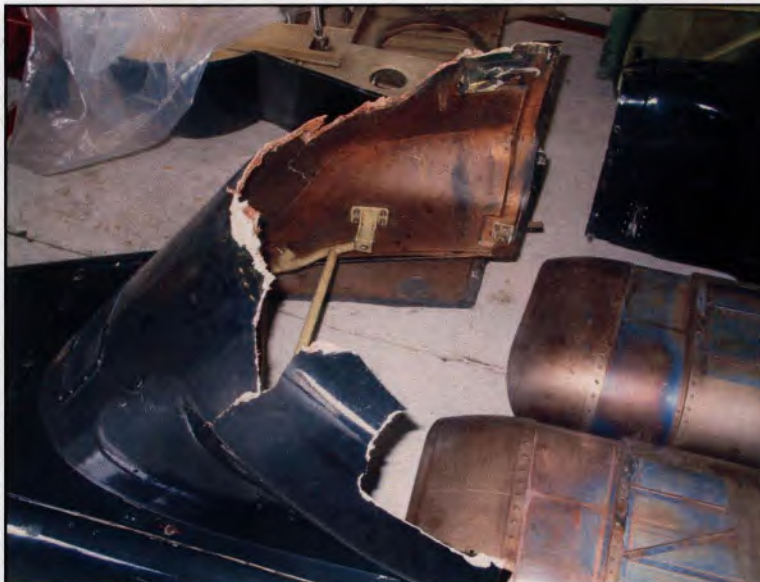
Figure 25 - Forward upper cowling debris from similar Bell 412 accident, showing damage as a result of pitch change links impacting the cowling.
(Picture Source: Bell)

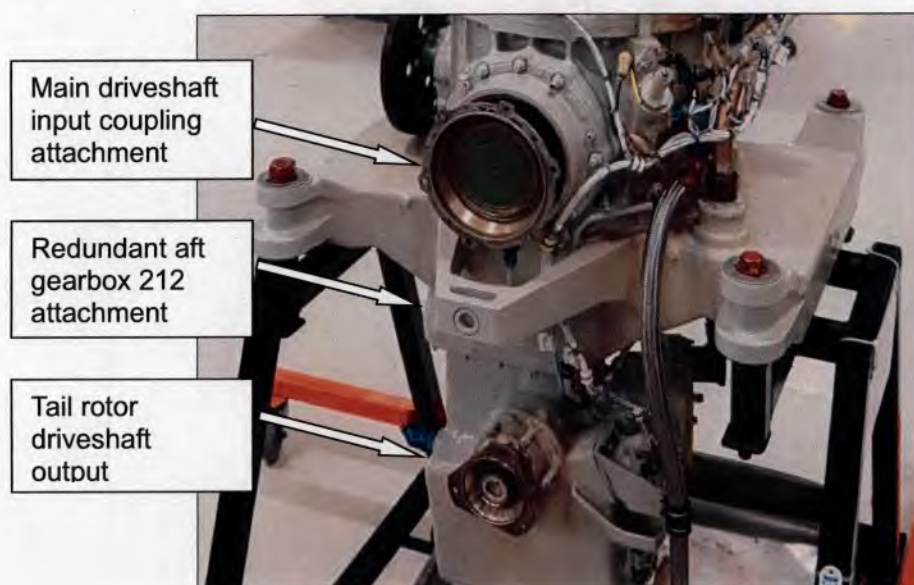
Figure 26 – Rear view of main gearbox uninstalled from aircraft
(Picture Source: SI Panel)

1.4.101. **Summary of main gearbox movement.** The main gearbox moved by an amount greater than 7.5° of misalignment at the forward outer coupling causing it to fail. Forward movement by this amount also caused consequential damage as the pitch change links cut through the forward upper cowling by 110 mm. The Panel concluded that the main gearbox moved forward during the accident by an amount greater than during normal operation. The Panel then sought to determine the cause of excessive main gearbox movement.

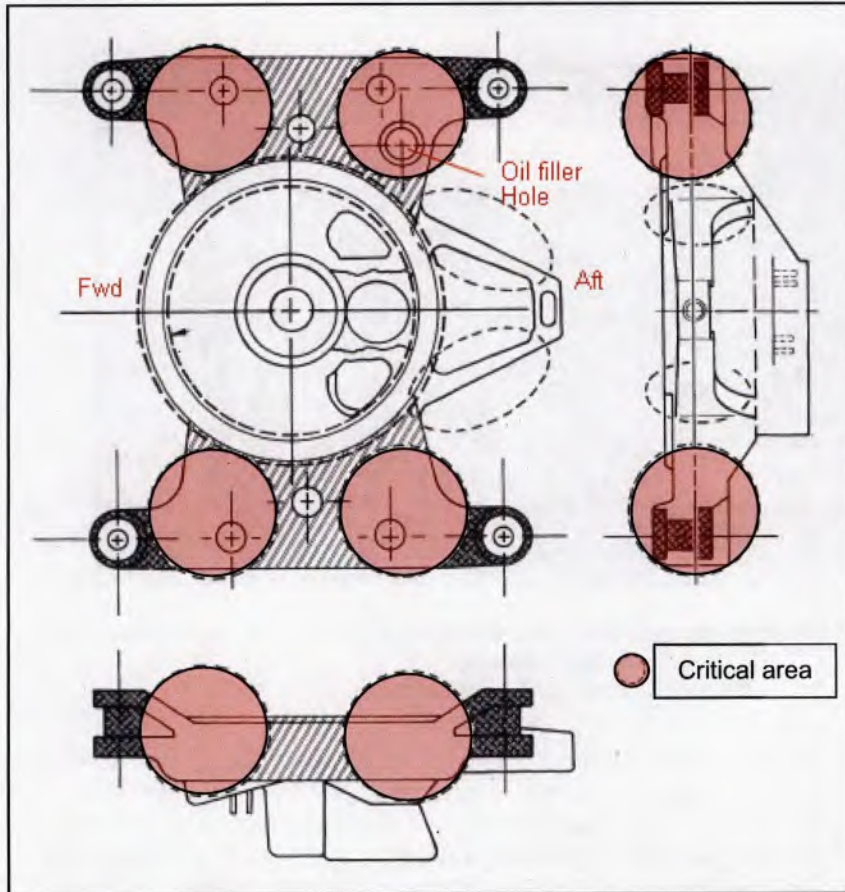
Figure 30 - Critical areas of main gearbox support case.

²³ Finite Element Analysis is a computerised analysis method to envisage how a manufactured product will react to the physical world. The analysis can predict if the product is likely to break, tear, wear, or behave in the way it was designed.

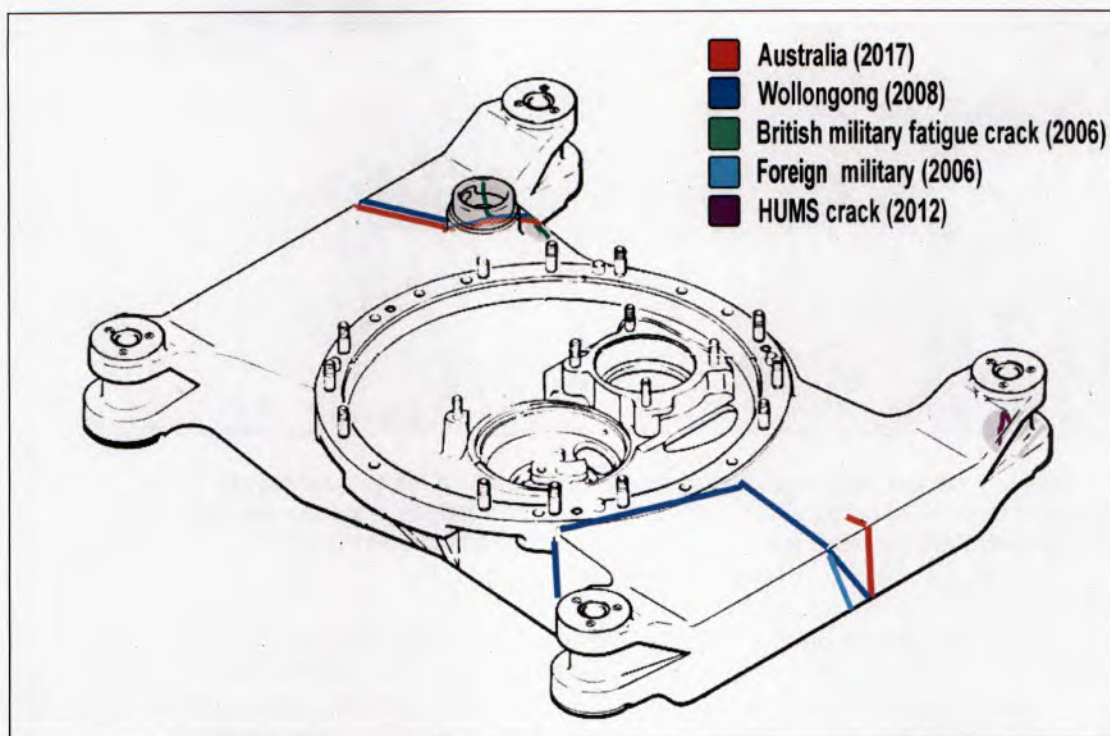
Figure 31 - Diagram showing the location of 5 previous support case failures.

1.4.107. **Examples of support case failure.** The Panel found a total of 5 reported instances of main gearbox support case cracking: a British military aircraft support case fatigue crack in 2006; an incident (provided by Bell) where analysis of Health Usage and Monitoring System (HUMS) data led to the discovery of a support case crack in 2012; overload of a support case in Wollongong, Australia following severe vibration in 2008; a foreign military support case crack (Provided by Bell) in 2006; and an incident in Australia of a crack found in the support case following severe vibration in 2017. There were a further 2 instances of cracking within Canadian Forces' gearbox support cases, "right hand transmission support cracked 5mm long" and "Cracked on forward right hand mount". Limited information prevented further analysis of the Canadian examples. The 5 non-Canadian incidents of cracking were all in or close to a critical area of the support case. Overlaying all of these incidents on a diagram of the support case demonstrated the most likely failure locations on ZJ241's support case because most of the cracks were almost coincident with each other (Figure 31). These incidents will now be individually discussed as case studies in support of determining the cause of the accident:

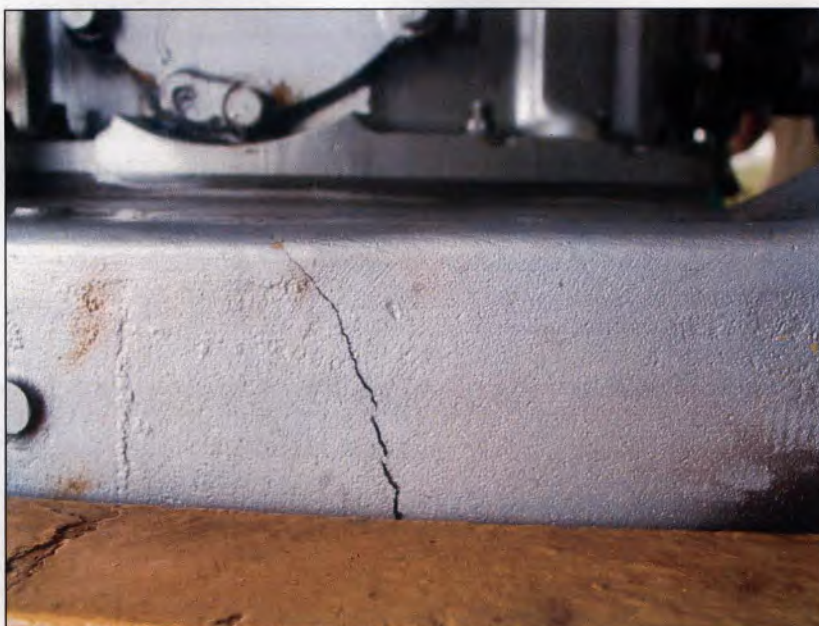
Figure 35 – Foreign military support case crack (2006).
(Picture Source: Bell)

f. **Foreign military support case crack (2006).** It was reported that shortly after landing on a grass pad and while light on the skids, the pilot felt the helicopter moving left and aft. In response, the pilot applied full right forward cyclic. The helicopter bounced forward approximately 34 ft and rotated slightly to the right. Airframe damage was limited to areas surrounding the gearbox. Amongst other damage, the forward pylon cowling was damaged consistent with main rotor pitch change link contact during the accident. The main drive shaft inner coupling was reported as becoming decoupled from the outer coupling and some chipped teeth were observed on the inner coupling. A large crack on the transmission support case in the vicinity of the right hand forward mounting leg was observed (Figure 35). The support case was sent to Bell Helicopter for laboratory examination. No features consistent with a fatigue failure mechanism were found on the crack's fracture surface; only features consistent with over-stress were observed. Extensive fretting was found under the left-hand forward pylon isolation mount between the mount spacer and channel. The two aft bolts fitted to the left-hand forward mount had longer grip lengths than required by the engineering drawing and exhibited contact damage from the bolts being tightened against the nut-plates. A total of three of the left-hand forward mount bolt locations had bolts installed that were not as specified, as well as one incorrectly specified bolt in the left-hand aft mount and two incorrectly specified bolts fitted to the right-hand aft mount.

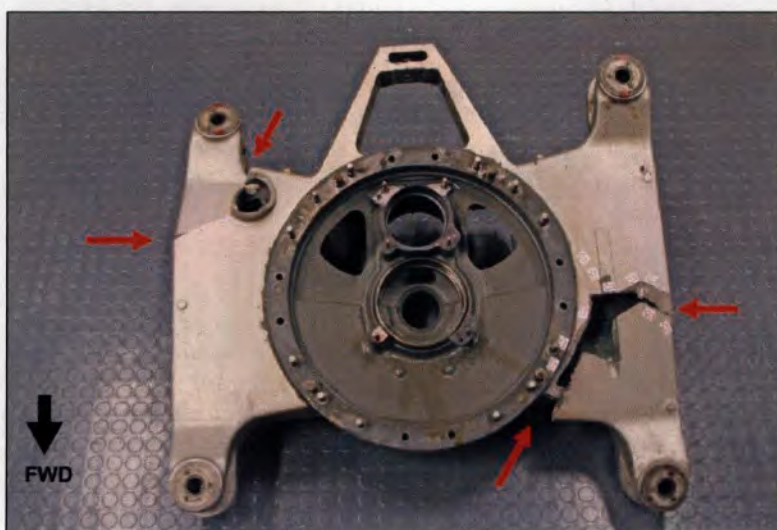
Figure 36 - Wollongong accident support case.
(Picture Source: Australian Transport Safety Bureau)

g. **Wollongong (2008).** While conducting training at Wollongong airfield the aircraft was landed on the runway and developed severe vertical airframe vibrations resulting in reduced pilot control. In an effort to mitigate the vibrations the aircraft was lifted back into the hover, however the vibrations increased in severity. The pilot lowered the collective to land again and the aircraft made a hard landing, resulting in damage to the gearbox. The fault was traced to excessive free-play introduced into the 'collective control run' at overhaul. This allowed extra vibration and lack of controllability issues to develop. The support case was fractured at the forward left and rear right corners (Figure 36).

Wollongong (Australia), 2008 resulted in overload of the support case following a severe vertical landing. In this incident the skids were deformed underneath the fuselage and bent outwards demonstrating how failure may occur as a result of a heavy landing. The inter-skid distance at the maximum all-up-mass was given as 2.8 m in the aircrew manual, and the LIDAR image of the crash site estimated this distance as 2.82 m at the rear of the skids and 2.96 m at the front of the skids. The skids were visibly intact after the crew had escaped and this was supported by photographic evidence and witness accounts. Subsequently, fire destroyed much of the skid frames and the fuselage collapsed. It was not possible to determine if the fuselage collapsing on the skids, post fire, had pushed them slightly apart or if this was an indication of the force of landing. DAIB conducted a "conditional inspection – after hard landing" on the available tail section in accordance with the Bell Maintenance Manual to identify if there was any damage that would indicate a hard landing. There was no structural damage evident in the tail rotor drive train or intermediate and tail rotor gearboxes, which indicated that a force of landing severe enough to cause structural damage was unlikely.

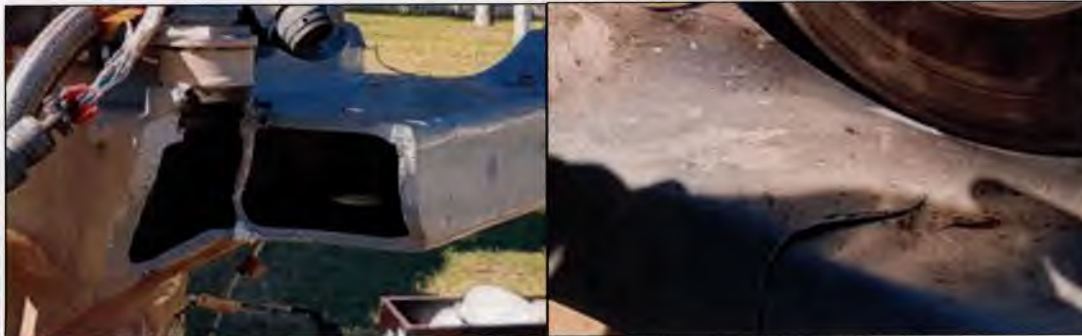
Figure 37 – Damage to the support case in the Australian accident (2017).

h. **Australia (2017).** Following uncommanded pitch changes during the previous flight, maintenance was carried out on the aircraft's autopilot system and ground checks were conducted to confirm the autopilot's serviceability. Aircraft start-up checks were completed without incident until the autopilot check commenced. At this point a vertical vibration began and quickly increased in intensity. The pilot raised the collective slightly to try to correct the situation however this increased the vibration further. The aircraft did not move laterally but continued "harsh bouncing" and the pilot believed that it did not leave the ground fully. The support case fractured due to overload forces at the rear right corner and on the left side in the vicinity of the rotor brake (Figure 37).

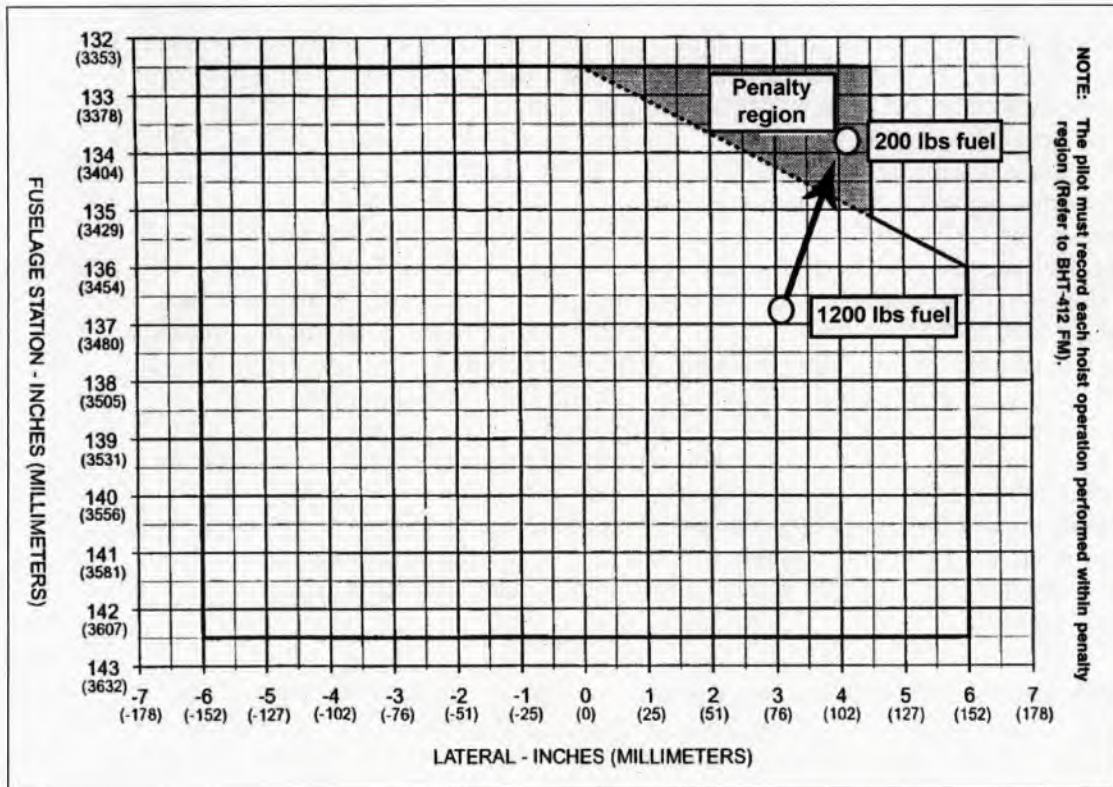
Figure 38 - Representative example centre of gravity calculation for hoist operations (5 crew members) showing entry into the penalty region for a typical winching sortie.

1.4.154. The Panel concluded that aircraft at RAF Valley were subjected to hoist operations within the penalty region. Although the effects of these operations were quantified for certain components, they would have increased the bending moment in the mast and so imparted an additional un-quantified and unrecorded fatigue load on the support case. Consequently, it was the Panel's judgement that hoist operations within the penalty region were likely to have accrued additional un-quantified fatigue consumption in the support case and was therefore a **contributory factor**.

1.4.153. Hoist centre of gravity penalty region. During the course of the Inquiry, the Panel were made aware that during a period of time, estimated to start in 2011 until August 2015, some aircraft flown at RAF Valley, including ZJ241, were subjected to a number of unrecorded fatigue significant events, whilst operating the hoist. At lower fuel states, it would have been possible for the aircraft to have been operated within the hoist centre of gravity penalty region (Figure 38), discussed further at (1.4.223). The operators assessed that this was likely to have occurred at an average of 4 times per month per aircraft. The penalty for this operation was applied to the same fatigue significant components as for the slope landing kit; the mast, the lower cone seat and the yoke.³⁹ There is a penalty incurred of 4 hours per excursion into the zone for each affected component. Reassessment and recovery of component lives was carried out by Cobham during the course of the Service Inquiry as a result of the issue being identified by the Panel, after being directed to by the Military Continuing Airworthiness Manager. The hoist centre of gravity penalty region represented a calculated use of the aircraft outside the normal operating limits but within the overall design limits and therefore did not constitute an unknown loading on the aircraft. However, Bell did not have data on the impact of operating within the penalty region on the support case, despite the purpose of the penalty region to account for the increased bending moment through the mast which translates to an un-quantified effect on the support case. Therefore, the Panel judged that operation within the penalty region did represent a higher than normal loading on the support case. As hoist operations moved the CofG further away from the ideal position, fatigue consumption is likely to have been higher and as no calculations were made it was not possible to quantify these effects. However, the total number of cycles over the 4 year period would have increased the fatigue consumption on the affected support cases.

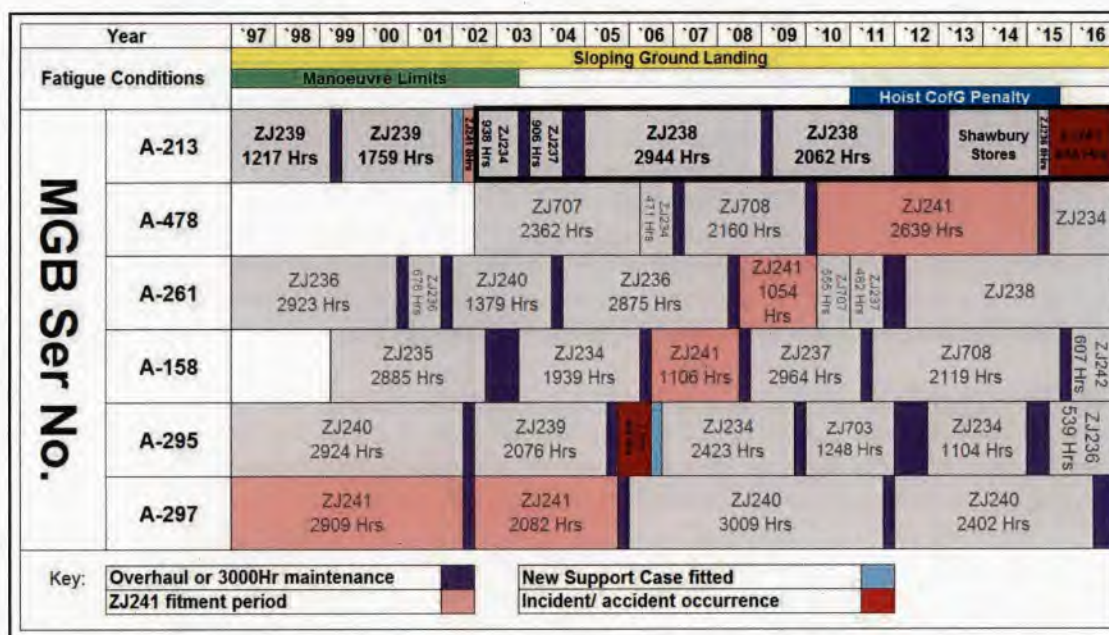
Figure 39 - ZJ241 gearbox installation history.

1.4.165. **Gearbox installation history.** There was only one previous support case failure in UK MOD service and it also occurred on ZJ241. This led the Panel to further investigate the gearbox and airframe history for ZJ241 and cross reference this to the fatiguing conditions (1.4.155) discovered throughout the course of the inquiry, in order to establish if there was any significant correlation. The Panel analysed all 6 gearboxes fitted to ZJ241 throughout its life. The original gearbox (A-297) flew on ZJ241 until 2005 but was briefly replaced by the gearbox involved in the accident (A-213) which was fitted and removed without flying in 2002, for unknown reasons. The 2006 fatigue crack gearbox (A-295) had the support case replaced and was returned to service after the incident. A further 3 gearboxes were fitted in-between the two incidents, and finally the gearbox involved in the accident was re-fitted in 2015. The accident gearbox had been fitted on a total of 6 aircraft during its life including ZJ241 (Figure 39).

a. Gearbox A-295 was exposed to the manoeuvre limits issue (1.4.144) over a period of 6 years and the rate of sloping ground landing issue over 9 years before it failed in 2006 (Figure 39). It was not possible to determine the loading severity of these conditions on the support case but Bell considered that exceeding the manoeuvre limits was one of two possible factors previously discussed in the fatigue crack incident in 2006 (1.4.107.c). The Panel assessed that exceeding the manoeuvre limits was the more likely of the 2 factors. A-295, was exposed to the maximum period of fatiguing conditions but this did not explain why other gearboxes may also have experienced similar loading but did not present similar fatigue cracks.

213 was also exposed to the hoist CofG issue (1.4.153) for approximately 1 year due to the gearbox being in storage, and an excessive number of sloping ground landings for 14 years (Figure 39). Although the magnitude of the hoist CofG issue could be determined for specified components, it was not possible to determine the loading severity of any of these issues on the support case.

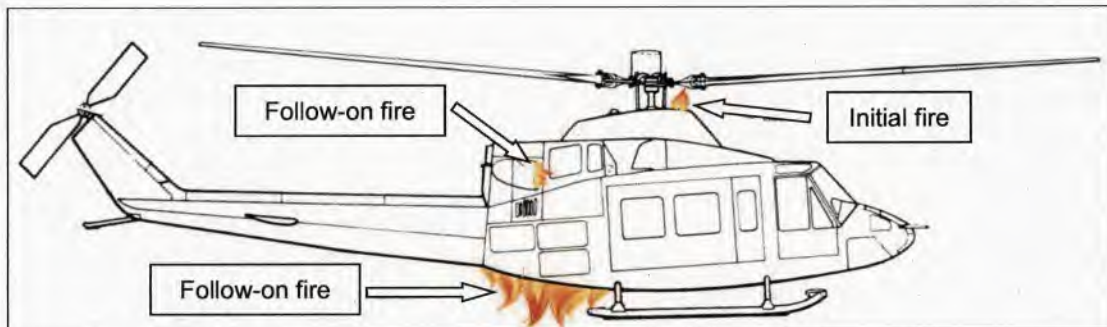
Figure 40 – Illustration of the fire locations as observed by Witness 5.

1.4.177. Fire destroyed most of the aircraft fuselage and burned for approximately 4 hours after the crew left the aircraft. Technical analysis determined that, had the fire been prevented or stopped before it was out of control, the aircraft may have been repairable and the accident may have been classified as an incident rather than an accident. There were 5 main indications of fire during the accident; flames in the vicinity of the rotor mast, fire bursting out from below the tail section and fuselage 'transportation joint', the main fuselage fire, the cockpit fire warning audio and the illumination of the No.2 'T-Handle'. The Panel sought to establish the cause of the fire and if an effective barrier to the fire could have minimised the level of damage. Each of the components of the fire is discussed below to establish the progression of the fire and its implications (Figure 40).

1.4.178. The fire was first seen in the vicinity of the rotor mast by the Passenger who signalled to alert the crew. The presence of a fire was acknowledged by the crew at this point. A fire warning was visible and audible on the CVR around this time, indicating that fire of sufficient heat was also present in the vicinity of at least one engine bay. The No 2 engine 'T-Handle' illuminated and the front crew emptied both fire bottles into the No 2 engine bay. The crew were further made aware of the fire when smoke entered the cockpit from above, this prompted the front crew to egress the aircraft. This also meant

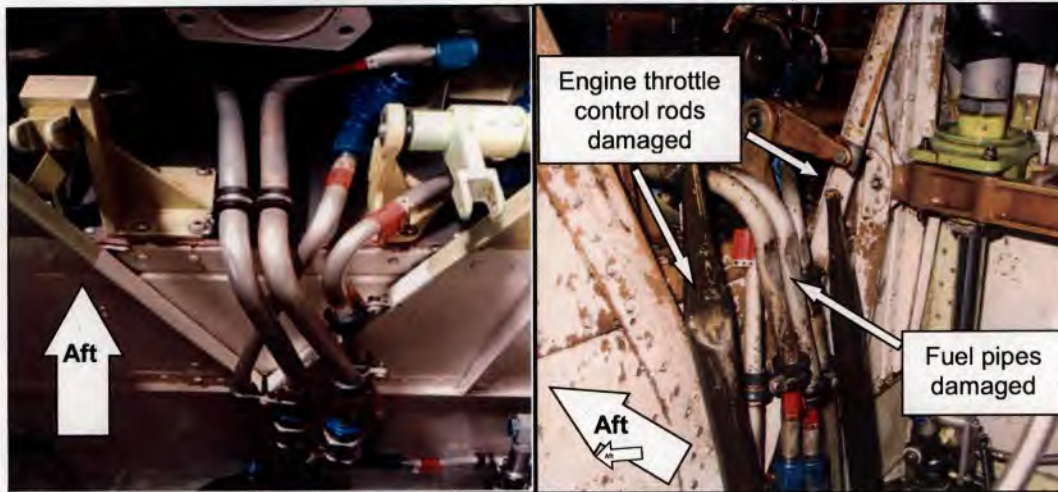
Figure 43 – [Left] MOD Griffin fuel pipe configuration with engine throttle control rods removed. [Right] Foreign military accident (2006).
(Picture Source: Left – SI Panel, Right – Bell)

The fuel pipelines and throttle control rods within the 'hell hole' were judged by the Panel as almost certain to have been damaged as a consequence of support case failure and subsequent gearbox movement during the accident. The fuel pipelines and throttle control rods were likely to have been damaged at the beginning of the accident sequence following movement of the gearbox and may explain why the engine speeds are seen to split around 2:01:46 (Figure 15). The fire was likely to have developed in the vicinity of the main gearbox and the 'hell hole', and blown upwards to be visible at the top of the cowling as a result of fuel spillage from the damaged pipelines. There was a significant quantity of fuel remaining in the fuel tanks that could have been fed via the booster pumps into the 'hell hole', sustaining the fire leading to complete destruction of the aircraft. The proximity and concentration of the engine controls and services into the confined space at the rear of the 'hell hole' provided a particular susceptibility to unrestrained motion of the gearbox. The follow-on fire emanating from the lower rear fuselage was likely to be the result of the contents of the fuel tank being released (Figure 44). In addition to the fire risk, the panel assessed that the configuration of the pipelines represented a single point of failure because structural failure and subsequent movement of the gearbox could cause loss of fuel to both engines. The FAA stated that the aircraft was subject to FAR 21.101 (Product Change Rule) or 'grandfather rights', thus any 412 derivatives only had to meet the certification basis at the time of their original Type Certification. The Panel did not conduct an assessment of the past and present regulations but noted that the Griffin safety case at the time of the accident was based on the Bell 412 Type Certificate. The Panel **observed** that there was a potential difference between the safety standards at the time of application for a Type Certificate and the safety standards in current regulation and that the safety case for older aircraft should take this into consideration for the risks to remain tolerable and as low as reasonably practicable.

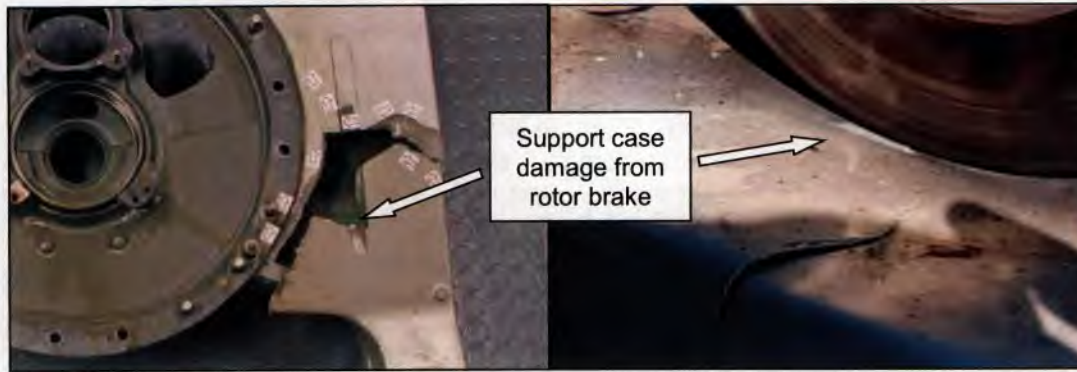
Figure 45 - Two examples of rotor brake contact with main gearbox support cases during an accident.

1.4.184. The crew reported a sound during the accident that was described as a chainsaw chewing through concrete. The Panel judged that this was more likely than not due to a high speed rotating metal component like the rotor brake making contact with another metallic object such as the support case. The rotor brake position on the gearbox provided approximately 2 mm of clearance between the brake disc and the support case. This has no adverse effect during normal operation. However, previous incidents have shown that during gearbox support case structural failure, this small rotor brake clearance may cause the disc to impact the case (Figure 45), presenting an ignition source and therefore increasing the potential risk of fire. The Panel concluded that the most likely ignition source was metal on metal contact. Metal on metal contact occurred as a result of the ejection of the forward outer coupling through the aircraft and was also likely to have occurred as a result of rotor brake interaction with the support case.

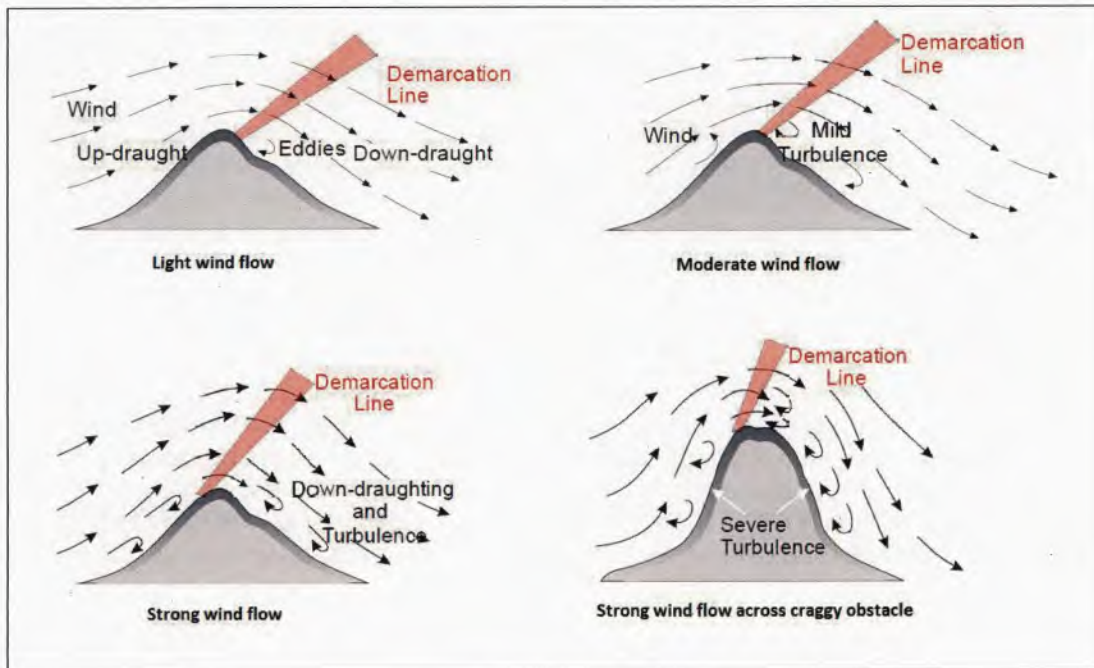
Figure 46 - Wind patterns over features with varying strengths
(Picture source: AP3456.49)

1.4.194. **Demarcation line and turbulence.** The demarcation line is where the airflow (wind) travelling over a feature breaks away from a smooth laminar flow and so turbulence results (Figure 46).⁴⁸

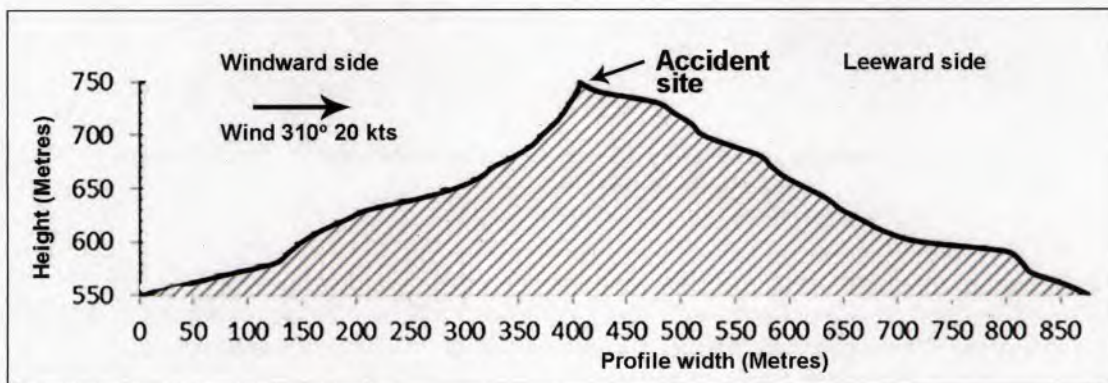
Figure 47 - Profile through the summit of Yr Aran, on the heading of the wind.

1.4.195. The profile of Yr Aran shows a steeper craggy section on the windward side of the hill which would have increased the steepness of this demarcation line (Figure 47).

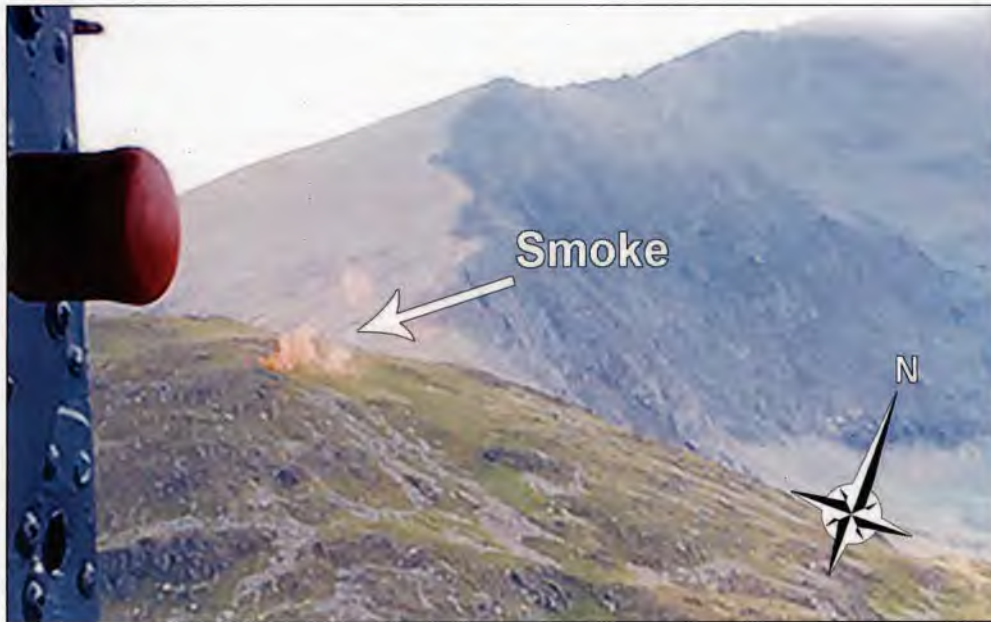
1.4.196. The hill was also part of a ridgeline that provided a 'wall' feature for the wind to divert over. This created a complex three dimensional demarcation 'plane'. Aircraft Commander A described going through the demarcation line quite smoothly during the first approach to the lower point on the same ridge and that the approach was absolutely normal. While not a perfect comparison to the actual accident site, the orientation of the ridge to the wind was similar in both cases. Both the Instructor Crewman and Student Pilot noted that the smoke canister fired during the recce, while slightly down-draughting on the lee-side of the hill, did not indicate turbulence (Figure 48).

Figure 48 – Photo of smoke (taken approximately 15 seconds after deployment), fired during recce to the pinnacle.
 (Picture Source: Aircraft Commander B)

1.4.197. The Crewman Instructor described the wind flow on the leeward side of the mountain as down drafting air but not turbulent, just the line of the flow of air going across the top of the mountain. The Crewman Instructor was focused on the task at the time and as such the Panel judged this to be the most accurate assessment of the level of turbulence. The Aircraft Commander of the Squirrel stated the conditions were not overly turbulent during the approach to the pinnacle, in an aircraft that weighed less than half that of the Griffin and therefore more susceptible to turbulence. The Passenger (flying the Squirrel), hadn't noted any particular turbulence or demarcation line issues, having flown through the demarcation line on a direct approach into wind, perpendicular to the ridgeline. Turbulence, rather than absolute wind strength, during the landing would have had more effect on aircraft handling. This is because any changes to wind speed vary the lift created by the main rotor blades which in turn require handling inputs to maintain the helicopter in a steady position. Handling would also have been more sensitive once in the skids light position due to the pitch response rate during a nose upslope landing. Therefore variations in wind speed combined with pitch response rate would have increased the difficulty of the landing. The crew did not experience any unusual weather and there was no evidence that handling of the aircraft was adversely affected leading up to the accident. In addition, the Panel assessed that the conditions at the time of the accident were within the competency of the crew.

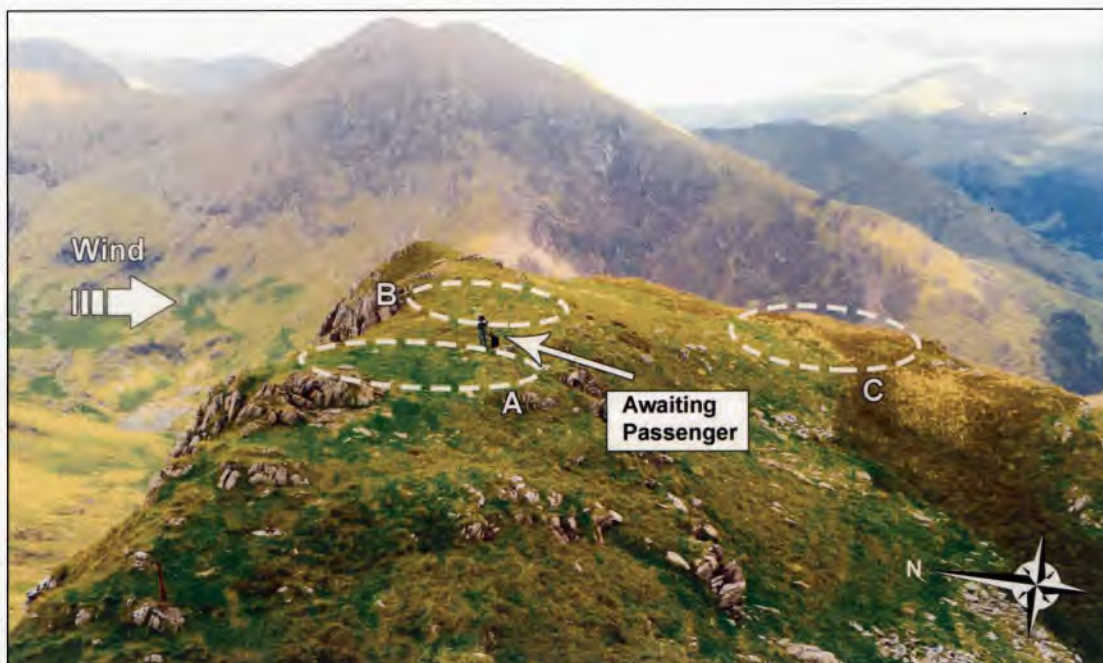
Figure 49 - Landing areas on Yr Aran.
(Picture Source: Aircraft Commander B)

1.4.200. The general landing area, on Yr Aran, was initially selected by Aircraft Commander B during the planning phase. It was chosen due to its classic shape as a pinnacle, its impressive nature and because it has a low volume of use by the general public. The pinnacle was described as the most classic looking pinnacle that was infrequently visited by walkers. The mountain has a number of possible landing points. A variety of options exist along the summit ridge, Area A and B (Figure 49) and a lower shelf of flatter ground immediately to the south of the ridge, Area C (Figure 49) which was also often used by members of 202(R) Sqn. The grid of the landing site (SH605516) was accurate to 100m and therefore not a specific point on the top of the mountain, this left an element of interpretation to the crew flying the approach regarding the exact landing point. The crew were free to choose the best location for the conditions at the time which included, but was not limited to, the 3 areas (Figure 49).

1.4.201. As the wind was perpendicular to the ridge all landing points on the ridgeline would have had comparable wind conditions. Area C was much further down the lee side of the mountain and therefore would be subject to greater risk of turbulence and down draughting air than the windward side of the mountain (Figure 49). Due to the increased
