Service Inquiry

Griffin HT Mk1
ZJ241, Snowdonia

09 August 2016

SERVICE INQUIRY INTO THE ACCIDENT INVOLVING A GRIFFIN MK1 ZJ241 AT YR ARAN, SNOWDONIA, WALES ON 9 AUG 16

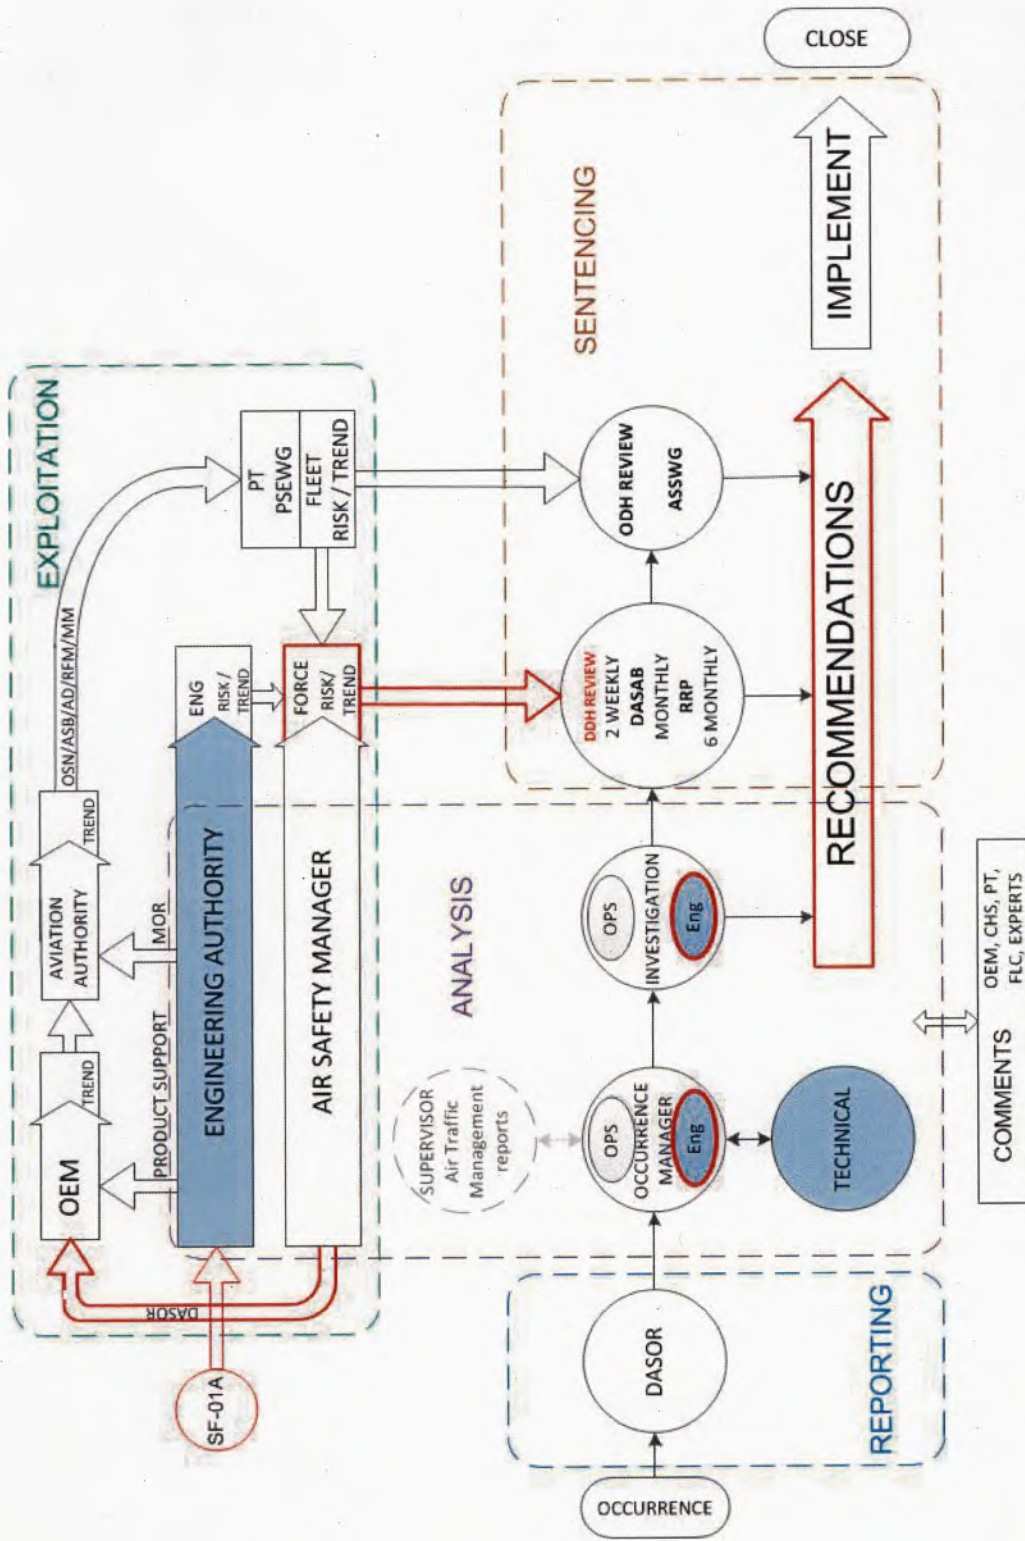
1.4.234. **Air safety information flows.** An analysis of the air safety information flows across DHFS and other Griffin organisations is represented in (Figure 50). The model is based on the ASIMS user manual but includes the additional necessary pathways that occur as a result of the MRCO construct.

Figure 50 - Analysis of air safety information flow for Griffin aircraft. Areas identified by the Panel for improvement are highlighted in red.

agencies. Air safety information flows (Figure 50) were further complicated by the number of reporting systems, the lack of access to ASIMS computer terminals and lack of ASIMS occurrence managers within the maintenance organisation. Trend analysis by all organisations had significant scope for improvement but the Panel opined that the most important of potential improvements was an ability to routinely normalise occurrence events against flying hours. More widely, a reliance on external agencies to provide trend analysis and safety assurance was not an effective strategy unless policy or contracts formalised this communication. The confluence of all air safety and airworthiness risks were managed at the DDH review group meeting and recommendations for improvements sentenced. Despite much activity to improve flight safety, DHFS had the lowest proportion of DASORs that contained recommendations and were sometimes closed where a recommendation should have been made. Although there were a number of observations and other factors resulting from air safety management, none directly contributed to the accident and therefore air safety management was **not a factor** in the accident.

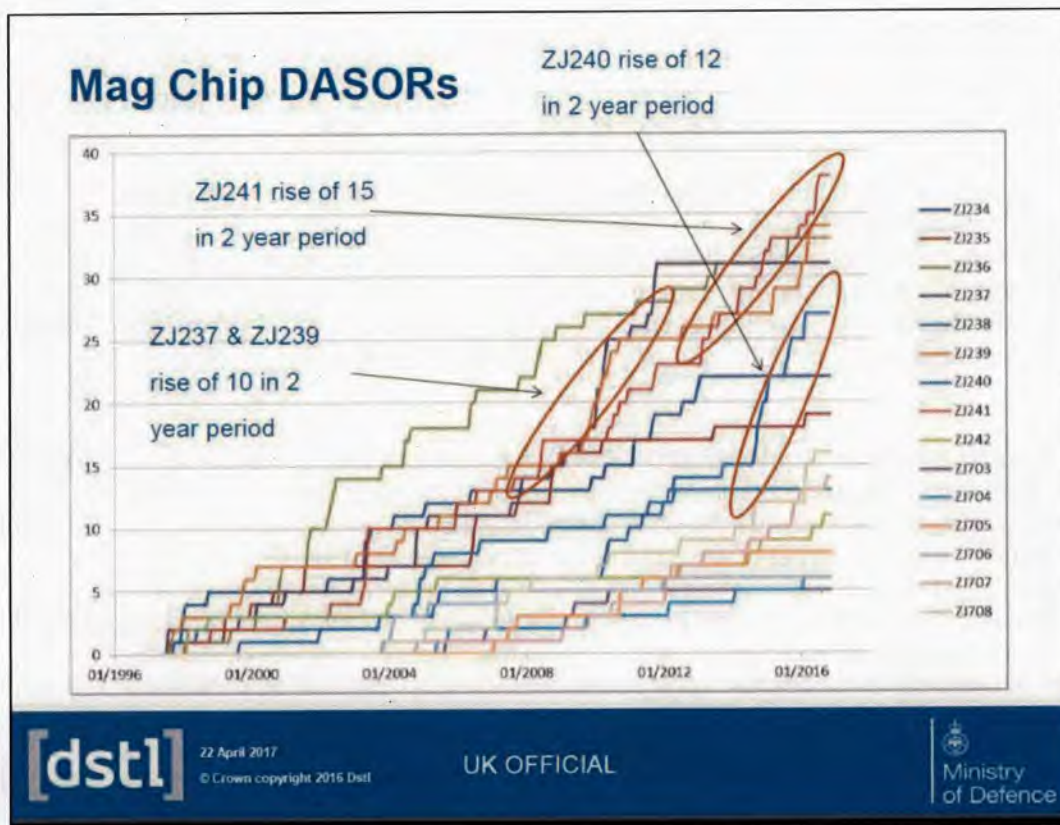
Figure 51 - DASORs containing magnetic chip faults. (Picture Source: DSTL)

1.4.244. A study was conducted by DSTL to identify if there were any predictors of gearbox failure within the available data that might have been identified during routine safety management reviews. The study indicated that it was not possible to have predicted the accident from the available information. The study did highlight that a trend in magnetic chip faults (the most reported technical occurrence for Griffin) in DASORs was present (Figure 51). However, it was not an accurate predictor of main gearbox failures or rejections. The man hours expended to investigate magnetic chip faults, in association with the sorties lost as a result, show that this was an area where efficiencies could have been made through trend analysis. A sample of the DASORs showed that action to identify magnetic chips as a potential issue or consider reliability improvements had not been taken. Additionally, the DASORs had not been linked with each other and no recommendations were found. This suggested to the Panel that either ASIMS was not the primary source of trending for the issue, that the issue was not deemed safety related or the issue was not recognised. Further, the DSTL report found that SPMAP PT safety team had procedures for trending, but identified that it had a weakness in identification of connections between potentially related DASORs and also in determining when a number of DASORs formed a meaningful pattern. The DSTL report determined that identifying an underlying issue within a collection of random events in the data was left to engineering qualitative judgement.

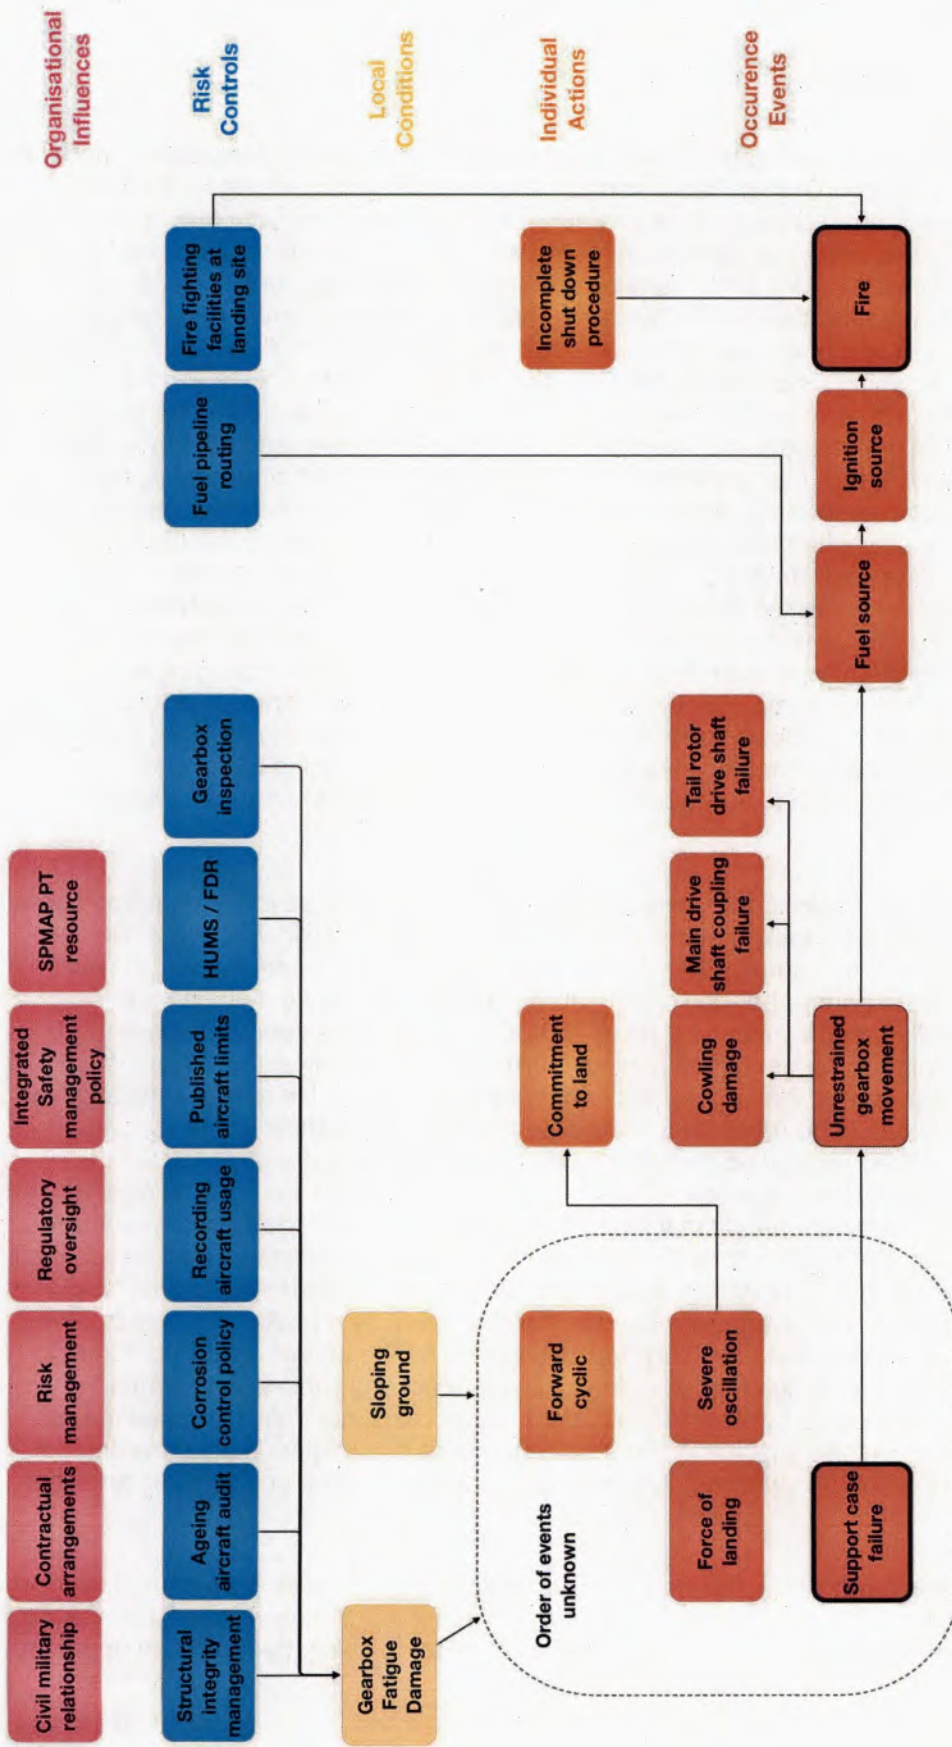
Figure 52 – Accident overview using the ATSB model.

1.4.263. The accident diagram (Figure 52) displays the interaction between the different factors and events that occurred during the accident using the ATSB model. It predominantly shows that there were a complex set of occurrence events and a large number of organisational influences and missing risk controls. It also demonstrates that there was no single activity in isolation that could have easily prevented the accident.
