Defence
Safety
Authority

Service Inquiry

HAWK T Mk1A XX204

SERVICE INQUIRY INVESTIGATION INTO ACCIDENT INVOLVING HAWK T MK1A XX204 AT RAF VALLEY ON 20 MAR 18

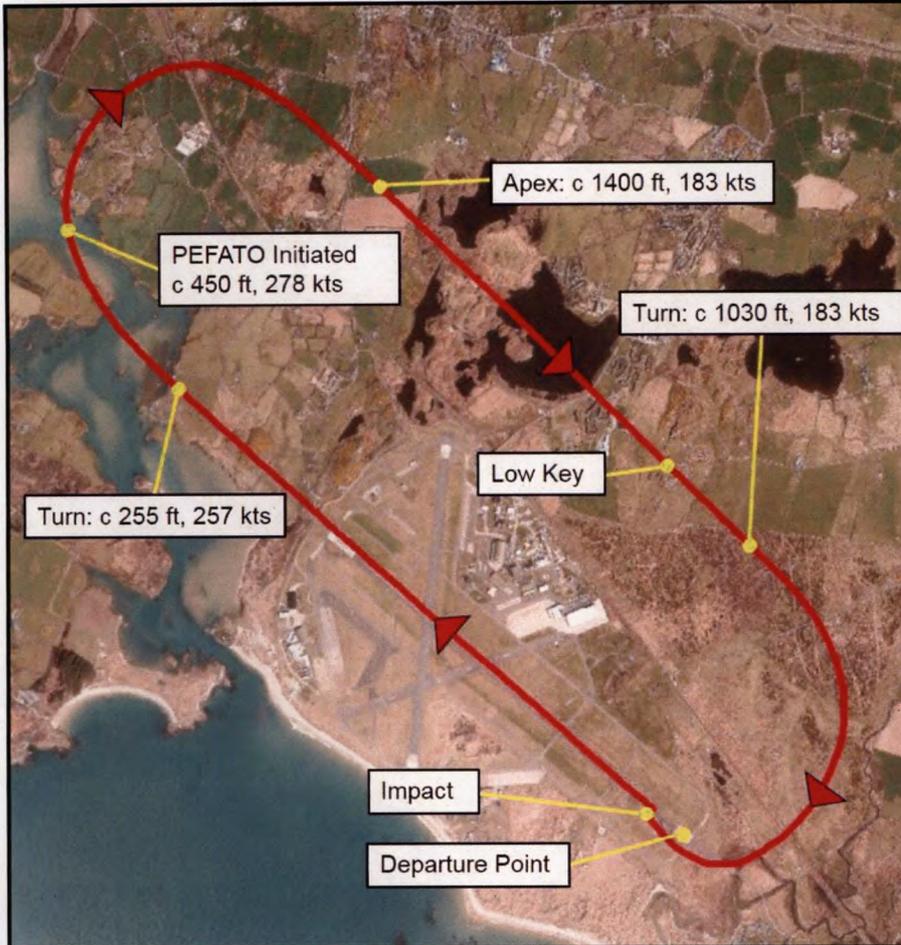
Figure 1.3.1 – XX204's ground track

1.3.7. After take-off, and on passing approximately 255 feet (ft) and at 257 knots (kts)¹³, the aircraft commenced a right turn. Having turned through 36°, and at circa 450 ft and 278 kts, R3 initiated a PEFATO. He transmitted to ATC that he had a simulated engine failure and was positioning for Low Key¹⁴ Runway 31; although he initially requested a high approach ATC offered a low approach¹⁵. XX204 achieved a maximum height on the downwind leg of approximately 1400 ft¹⁶ above ground level (AGL) and a speed of 183 kts. R3 reported Low Key when downwind and parallel to a position approximately halfway down the runway and 7 seconds (sec) later commenced a gradual right final turn towards the runway from circa 1030 ft and 183 kts. XX204's ground track is shown in Figure 1.3.1.

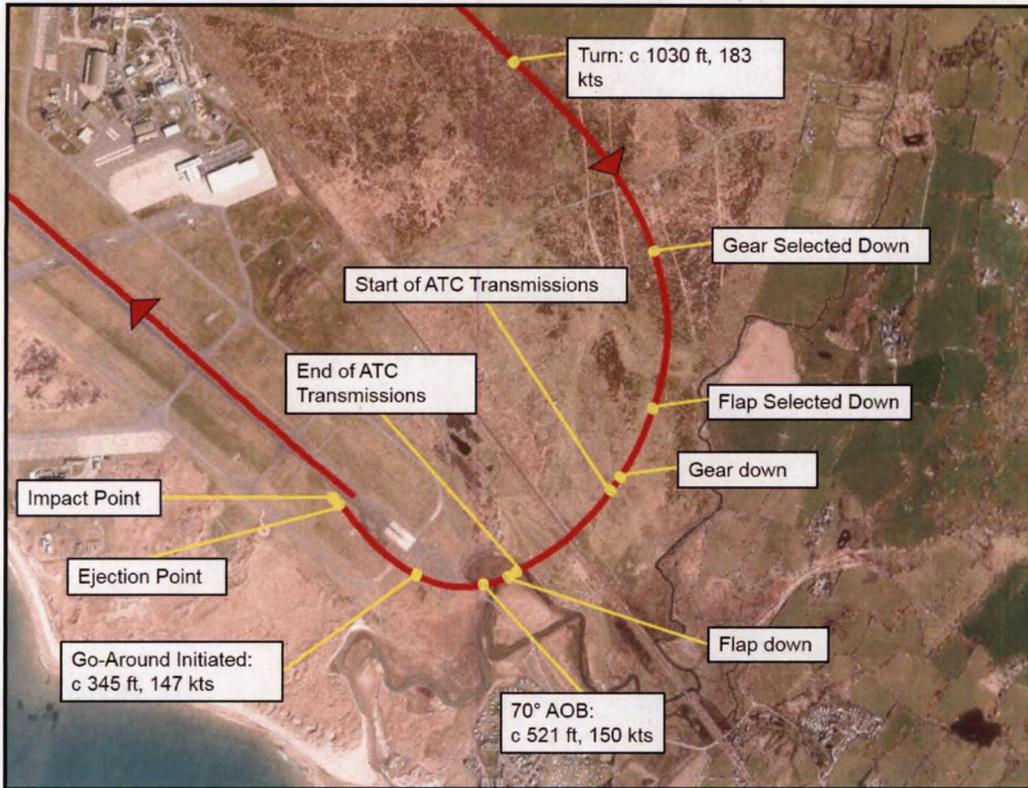
Figure 1.3.2 – XX204's ground track in the final turn

and a further wing drop experienced. Approximately 4.7 sec after the initiation of the go-around and with 15° right AOB, an essentially level pitch attitude and at 151 kts, the aircraft impacted the ground immediately prior to which the pilot ejected; the engineer did not eject from the aircraft. The time of impact was 1325 hrs. XX204's ground track in the final turn is shown in Figure 1.3.2.

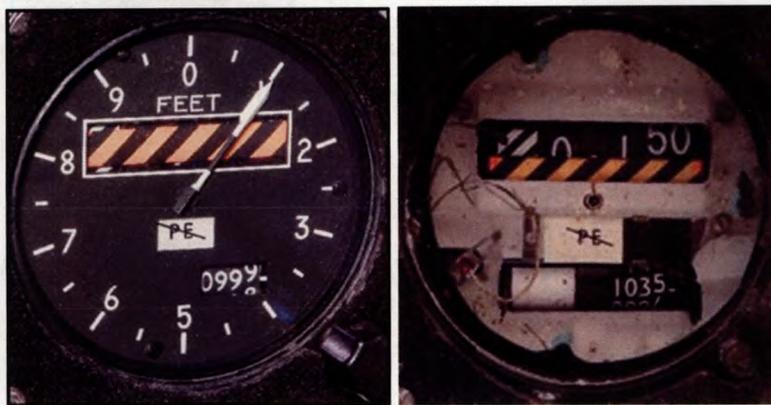
Figure 1.4.4 - Serviceable Hawk T Mk1 main altimeter (power off) and XX204's

1.4.136. Due to XX204's height parameters during the PEFATO sequence, and anomalies identified with the ADR height data, the Panel sought to establish, as far as was reasonably possible, whether R3 had set an incorrect pressure setting.

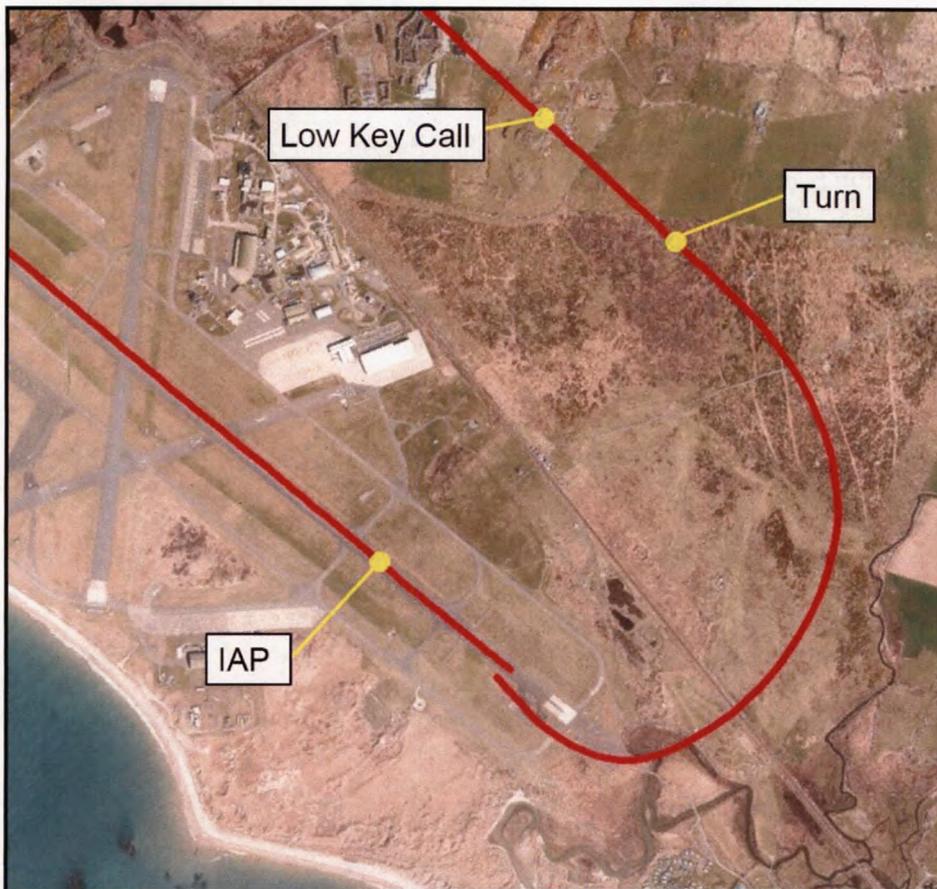
Figure 1.4.8 - Position of Low Key, IAP and turning point

1.4.171. R3 extended downwind beyond the point at which he called Low Key position in order to give himself more runway available for a potential landing (R3's intention was to go-around no lower than 300 ft). In interview R3 identified a location on the airfield that he had selected as his IAP, this was approximately abeam the position at which the finals turn was commenced. The IAP, Low Key and turn point are shown in Figure 1.4.8.

1.4.172. At the point R3 commenced the finals turn XX204 was gliding at approximately 183 kts at circa 1030 ft AGL with a lateral separation of approximately 1268 m from the runway. In the Panel's opinion, the profile flown up to the end of the downwind leg meant that the conditions were set that would make a successful final turn (rolling out on the runway centreline and having met the 'contract' parameters) extremely unlikely. The resultant manoeuvring during the final turn was very likely influenced by the combination of reduced height and lateral separation; once landing gear was lowered 45° AOB was used and speed reduced to approximately 170 kts⁸⁸. The subsequent high AOB was likely to have been used to lower the nose to attempt to maintain the minimum glide speeds and complete the turn in the room available, resulting in an increased ROD and flight path angle (FPA). At around the point of the go-around the aircraft stalled and there was insufficient height available for a successful recovery.

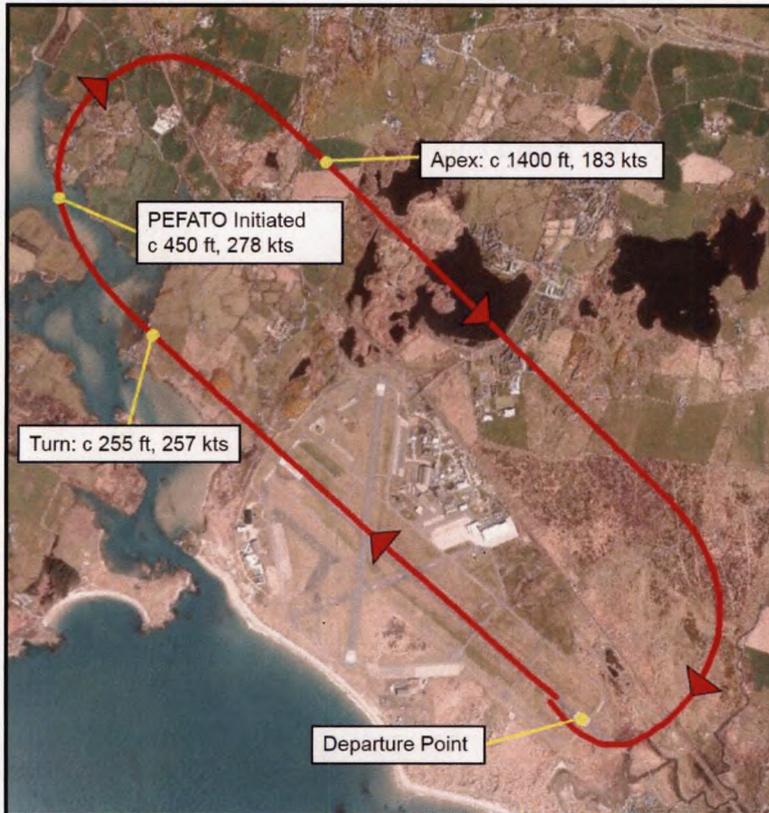
Figure 1.4.10 – Initial turn, PEFATO initiation and apex at start of downwind leg

1.4.180. At initiation, XX204 was less than a ¼ of the way around the upwind turn and had approximately 144° remaining to achieve the downwind leg heading. After completing a climbing right hand turn and converting speed to height using 18° nose up, 72° AOB and 2.9 g, XX204 achieved an apex at the start of the downwind leg of approximately 1400 ft⁹⁰ at a speed of 183 kts⁹¹. The initial turn, PEFATO initiation and downwind apex are shown in Figure 1.4.10.

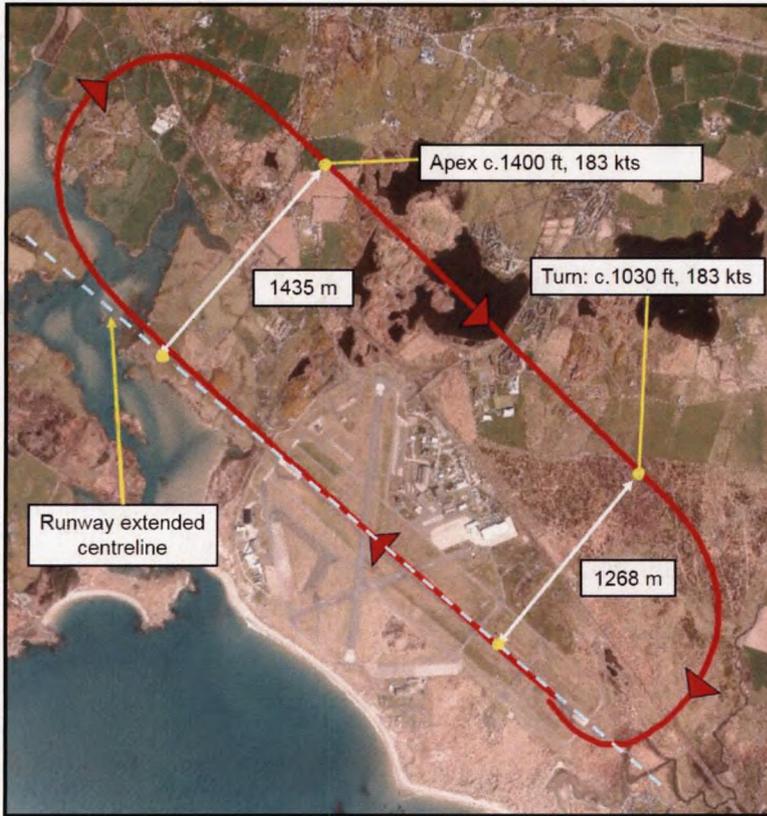
Figure 1.4.11 - XX204's ground track and downwind spacing

was aware of the surface wind and was reasonably happy where he had positioned the aircraft on the downwind leg. XX204's lateral displacement from the runway, at the end of the downwind leg, just prior to turning onto finals, was approximately 1268 m. XX204's ground track and downwind spacing are shown in Figure 1.4.11.

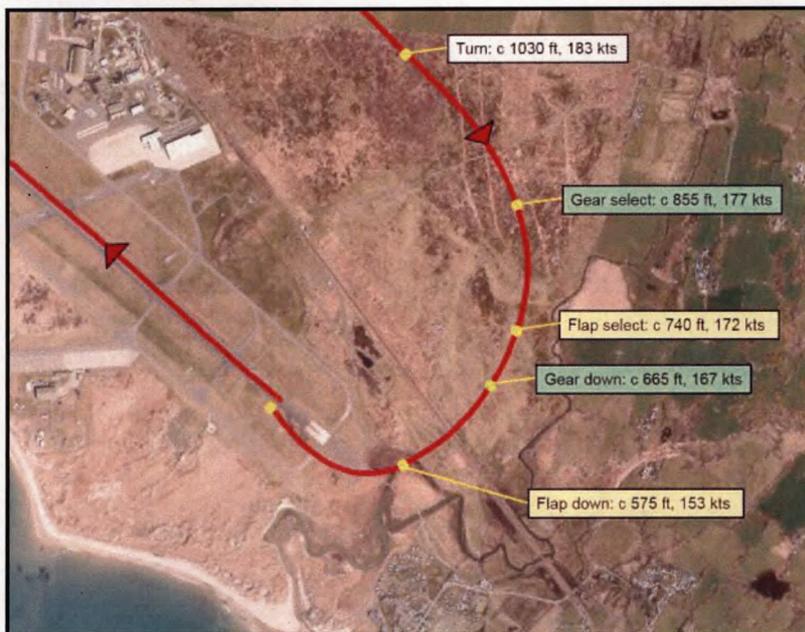
Figure 1.4.13 – Selection of landing gear and flap

1.4.199. In the Panel's opinion, the timings of R3's selections of landing gear and flap were appropriate. Delaying landing gear would have made little difference to the height profile¹⁰⁵, and delaying flap would have only exacerbated the fly-through of the runway centreline. The position of R3's selection of landing gear and flap is shown in Figure 1.4.13.

1.4.200. Within the context that R3's intention was always to fly a go-around, and not to perform a touch-and-go, the Panel concluded that the timing of down selection of landing gear did not affect the outcome and, therefore, was **Not a Factor**.

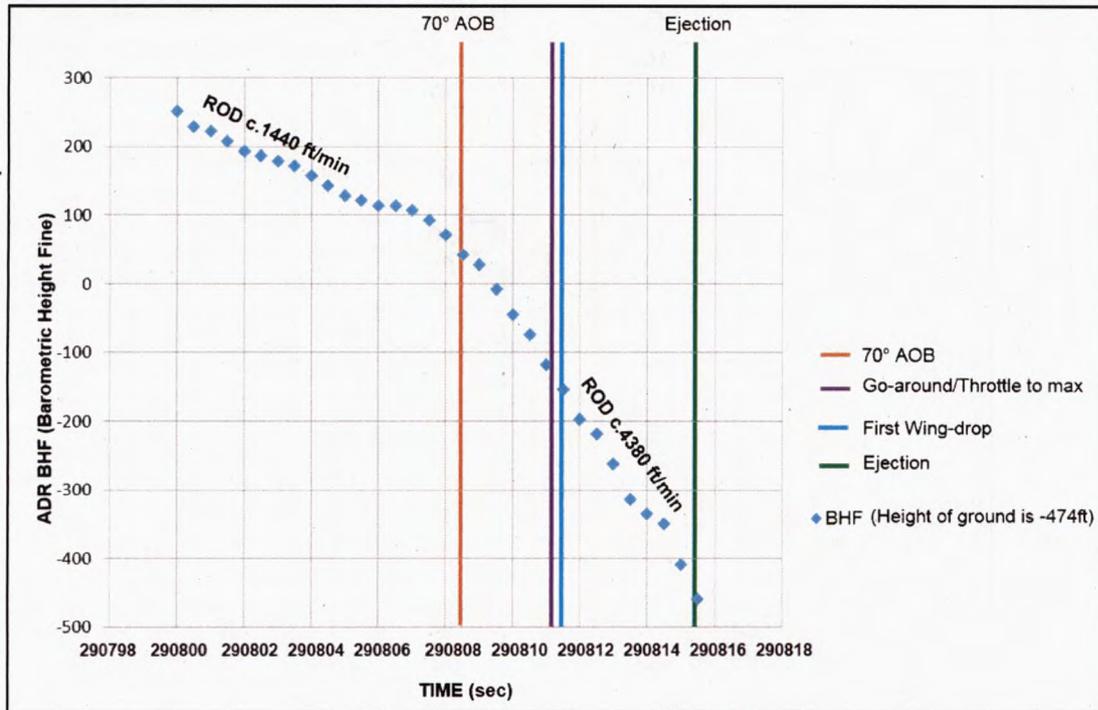
Figure 1.4.14 - Increase in ROD post 70° AOB

vertical speed indicator, indicating ROD. The Panel could not determine whether, in the 2.7 sec after the peak AOB and the initiation of the go-around, the difference between a ROD of 3250 ft/min or 4380 ft/min could be perceived by R3. ROD considerations are covered in more detail at para 1.4.257.

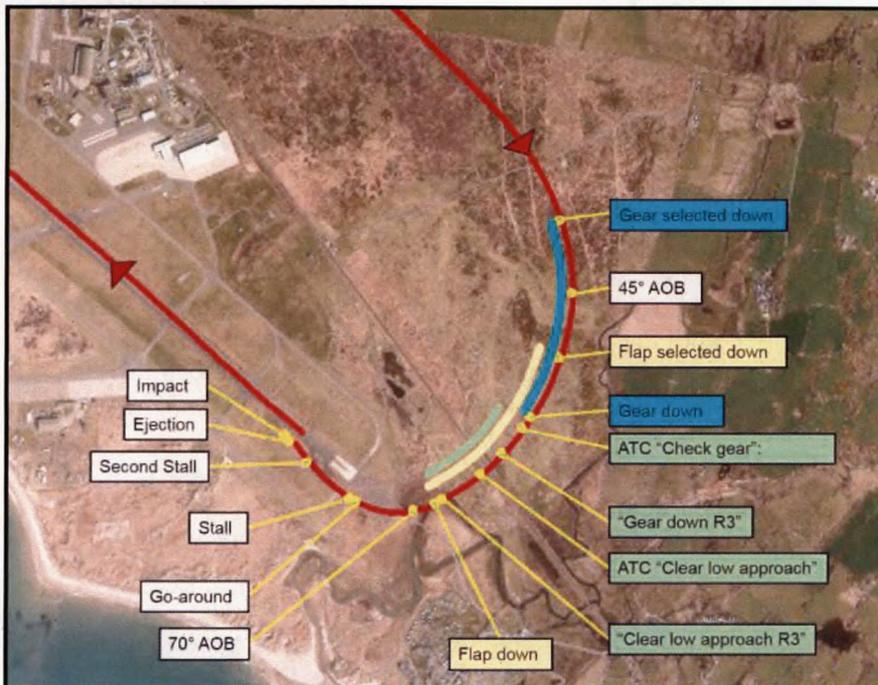
Figure 1.4.15 - XX204 key activities during final turn

1.4.212. Key activities during XX204's final turn are illustrated in Figure 1.4.15. As has been articulated, the overlap of flap travel and ATC transmissions culminated with the application of 70° AOB.

1.4.213. **Final turn summary.** Various flight and HSTF trials were flown and final turn modelling was carried out. All results indicated that even if R3 had used a high AOB earlier or taken landing gear and flap at different points during the turn, from XX204's position at the end of the downwind leg, it was extremely unlikely that XX204 could successfully fly a final turn and achieve the 'contract' and runway centreline. The timing of the ATC radio transmissions may have delayed R3's application of bank or resulted in the use of a higher AOB than intended. From the point at which 70° AOB was achieved the ROD increased to 4380 ft/min. The combination of ROD/FPA, AOB and associated g all culminated with the aircraft stalling coincident with the go-around initiation.

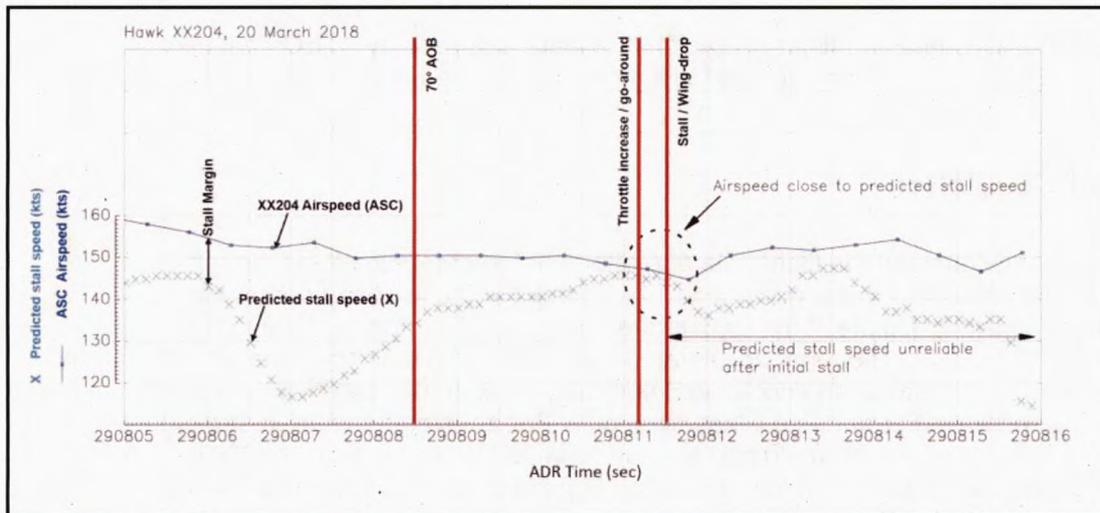
Figure 1.4.16 - Stall margin

1.4.223. Figure 1.4.16 shows the recorded airspeed and predicted stall speed of XX204, the difference being the stall margin, and shows the stall/wing drop as both converge. The go-around and the stall are within 0.3 sec of each other and effectively coincident. The time shown is 'ADR time' and is indicated on a 0.5 sec grid. Whilst the stall margin appears to be approximately 10 kts at time 290806, the flap is still travelling down at this point; until the flaps are fully down the predicted stall speeds are unreliable¹¹⁵. However, during the high AOB manoeuvre there appears to have been a reasonable stall margin.

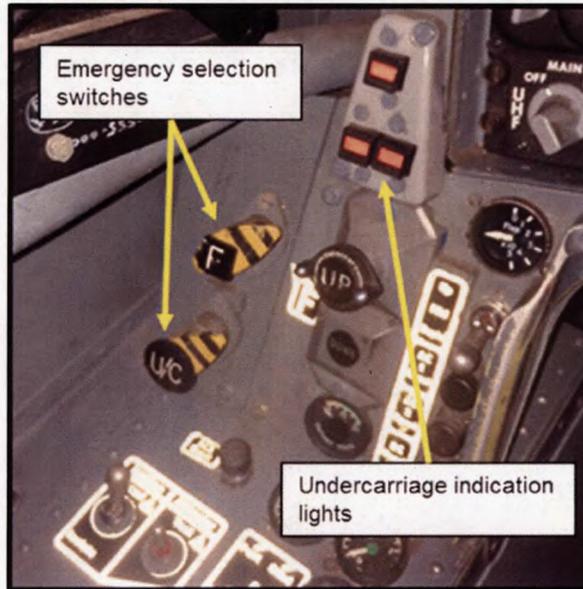
Figure 1.4.17 - Location of undercarriage and flap emergency selectors

1.4.335. Although the flap and landing gear systems were observed in the down configuration, the method of operation was unclear as the standby lowering selectors were recovered¹³⁵ with the red tell-tale bands visible, indicating that they had been activated, as shown in Figure 1.4.18.
